Access Compliance Report

Public Rights-of-Way

(Curb Ramps)

Intersection ID: 9858	Main Street: MERCURY_ST	Cross Street: N_DAVIDSON_ST	Location: SE
ADA ID: 0499AB9D08F3	Ramp Type: Perp	Initial Pass/Fail: Fail	Overall Compliance: No
Codes/Mitigation Info/Possible Solution		Field Measurements/Component Compliance	
Severity Score: 33.75

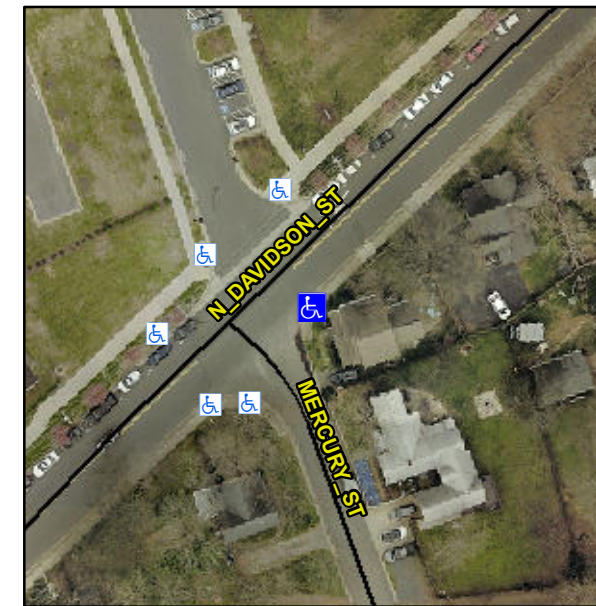
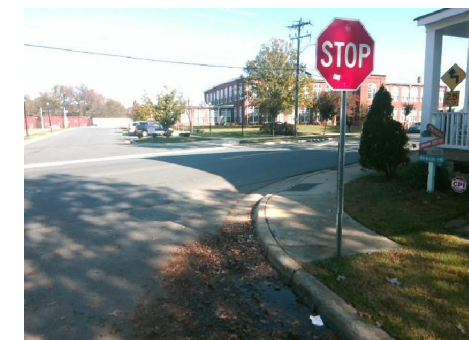
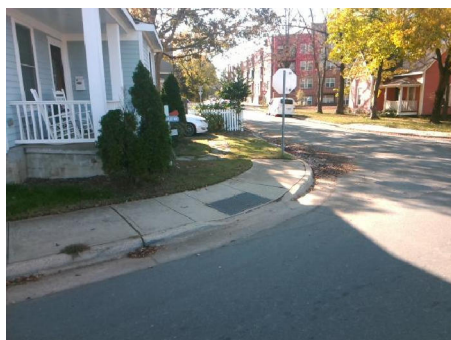
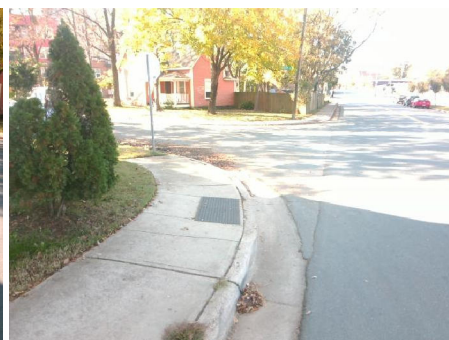
Not Found, R304.5.1, R304.2.2

Compliance	Description	Data	Compliance	Description	Data
N/A	Ramp Length (in)	59.0	No	Ramp Slope (%)	13.2
No	Ramp Width (in)	41.0	Yes	Ramp XSlope (%)	1.7
N/A	Flare Type LT	N/A	N/A	Flare Type RT	N/A
N/A	Flare Slope LT (%)	N/A	N/A	Flare Slope RT (%)	N/A
N/A	Flare Traversable LT?	N/A	N/A	Flare Traversable RT?	N/A
N/A	Landing Length (in)	N/A	N/A	DWS Provided?	N/A
N/A	Landing Width (in)	N/A	N/A	DWS Contrast?	N/A
N/A	Landing Slope (%)	N/A	N/A	DWS Length (in)	N/A
N/A	Landing X Slope (%)	N/A	N/A	DWS Full Width?	N/A
N/A	Landing Curb? (Y/N)	N/A	N/A	DWS Offset (in)	N/A
N/A	Shared Landing?	N/A			
N/A	Gutter Ponding?	N/A	N/A	Gutter Slope (%)	N/A
N/A	Gutter Lip Ht (in)	N/A	N/A	Gutter X Slope (%)	N/A
N/A	Painted X Walk1?	No	N/A	Painted X Walk2?	N/A
	X Walk 1 Direction	To N		X Walk 2 Direction	N/A
N/A	X Walk 1 Width (in)	N/A	N/A	X Walk 2 Width (in)	N/A
	X Walk 1 Slope (%)	4.6		X Walk 2 Slope (%)	N/A
	X Walk 1 X Slope (%)	0.2		X Walk 2 X Slope (%)	N/A

N/A	Ramp inside XWalk1?	N/A	N/A	Ramp inside XWalk2?	N/A
	Road Slope (%)	N/A	N/A	Clear Space?	N/A
	Road X Slope (%)	N/A	N/A	Clear Space to XWalk (in)	N/A
N/A	Any Obstructions?	N/A	N/A	Storm Grate/Utility Hazard?	N/A
	Obstruction Type			Storm Grate/Utility Type	
		N/A			N/A
			Yes	Surface Condition? (G/P)	Good

Remove & Replace Entire Ramp.
