Access Compliance Report

Public Rights-of-Way

(Curb Ramps)

Intersection ID: 28659	Main Street: HAMPTON_PLACE_DR	Cross Street: RIDGELINE_LN	Location: W
ADA ID: 04A32FF6A518	Ramp Type: PerpDiag	Initial Pass/Fail: Fail	Overall Compliance: No
		Severity Score: 10

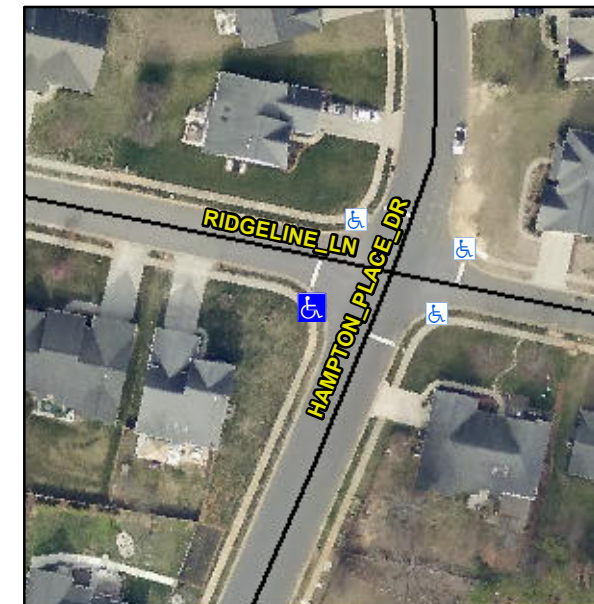
Compliance	Description	Data	Compliance	Description	Data
N/A	Ramp Length (in)	48.5	Yes	Ramp Slope (%)	5.7
No	Ramp Width (in)	47.5	No	Ramp XSlope (%)	3.8
N/A	Flare Type LT	N/A	N/A	Flare Type RT	N/A
N/A	Flare Slope LT (%)	N/A	N/A	Flare Slope RT (%)	N/A
N/A	Flare Traversable LT?	N/A	N/A	Flare Traversable RT?	N/A
N/A	Landing Length (in)	N/A	N/A	DWS Provided?	N/A
N/A	Landing Width (in)	N/A	N/A	DWS Contrast?	N/A
N/A	Landing Slope (%)	N/A	N/A	DWS Length (in)	N/A
N/A	Landing X Slope (%)	N/A	N/A	DWS Full Width?	N/A
N/A	Landing Curb? (Y/N)	N/A	N/A	DWS Offset (in)	N/A
N/A	Shared Landing?	N/A			
N/A	Gutter Ponding?	N/A	N/A	Gutter Slope (%)	N/A
N/A	Gutter Lip Ht (in)	N/A	N/A	Gutter X Slope (%)	N/A
N/A	Painted X Walk1?	No	N/A	Painted X Walk2?	No
	X Walk 1 Direction	To E		X Walk 2 Direction	To NE
N/A	X Walk 1 Width (in)	N/A	N/A	X Walk 2 Width (in)	N/A
	X Walk 1 Slope (%)	3.0		X Walk 2 Slope (%)	2.6
	X Walk 1 X Slope (%)	4.8		X Walk 2 X Slope (%)	4.1

N/A	Ramp inside XWalk1?	N/A	N/A	Ramp inside XWalk2?	N/A
	Road Slope (%)	6.3	N/A	Clear Space?	N/A
	Road X Slope (%)	1.8	N/A	Clear Space to XWalk (in)	N/A
N/A	Any Obstructions?	N/A	N/A	Storm Grate/Utility Hazard?	N/A
	Obstruction Type			Storm Grate/Utility Type	
		N/A			N/A
			Yes	Surface Condition? (G/P)	Good

Possible Solutions:

Remove & Replace Curb Ramp With Two New Directional Ramps or Equivalent.

R304.5.1, R304.5.3
