# Access Compliance Report

## Public Rights-of-Way

### (Curb Ramps)

Intersection ID: 23730	Main Street: PROVIDENCE_RD	Cross Street: CEDAR_CROFT_DR	Location: SW
ADA ID: 04A6E08670C8	Ramp Type: Perp	Initial Pass/Fail: Fail	Overall Compliance: No
Severity Score: 42.5			
Codes/Mitigation Info/Possible Solution		Field Measurements/Component Compliance

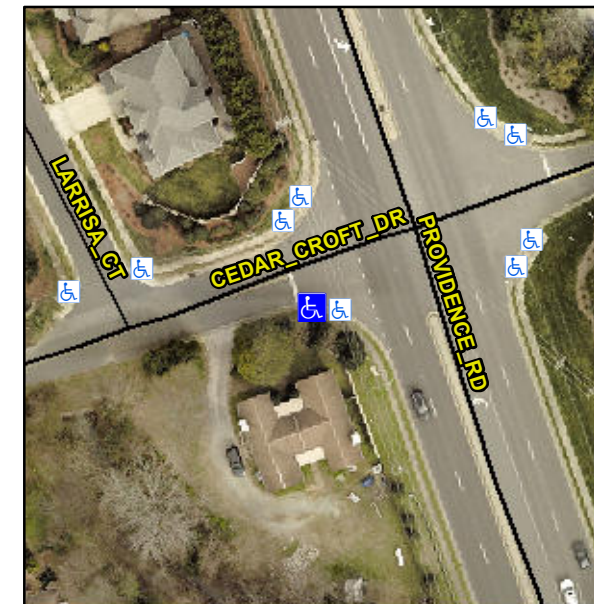
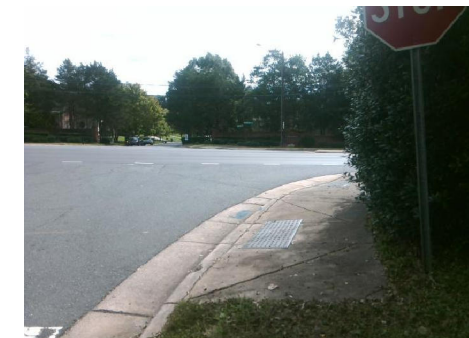
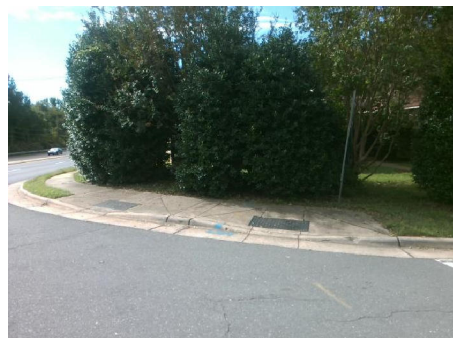
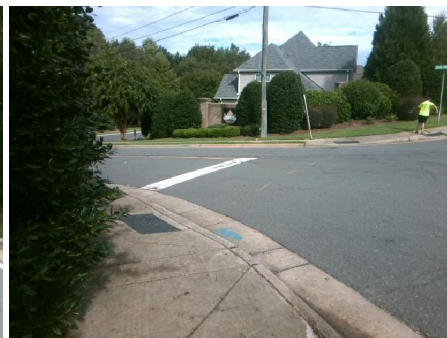
Compliance	Description	Data	Compliance	Description	Data
N/A	Ramp Length (in)	71.0	No	Ramp Slope (%)	10.9
No	Ramp Width (in)	34.0	No	Ramp XSlope (%)	5.6
N/A	Flare Type LT	N/A	N/A	Flare Type RT	N/A
N/A	Flare Slope LT (%)	N/A	N/A	Flare Slope RT (%)	N/A
N/A	Flare Traversable LT?	N/A	N/A	Flare Traversable RT?	N/A
N/A	Landing Length (in)	N/A	N/A	DWS Provided?	N/A
N/A	Landing Width (in)	N/A	N/A	DWS Contrast?	N/A
N/A	Landing Slope (%)	N/A	N/A	DWS Length (in)	N/A
N/A	Landing X Slope (%)	N/A	N/A	DWS Full Width?	N/A
N/A	Landing Curb? (Y/N)	N/A	N/A	DWS Offset (in)	N/A
N/A	Shared Landing?	N/A			
N/A	Gutter Ponding?	N/A	N/A	Gutter Slope (%)	N/A
N/A	Gutter Lip Ht (in)	N/A	N/A	Gutter X Slope (%)	N/A
N/A	Painted X Walk1?	No	N/A	Painted X Walk2?	N/A
	X Walk 1 Direction	To NW		X Walk 2 Direction	N/A
N/A	X Walk 1 Width (in)	N/A	N/A	X Walk 2 Width (in)	N/A
	X Walk 1 Slope (%)	4.6		X Walk 2 Slope (%)	N/A
	X Walk 1 X Slope (%)	7.3		X Walk 2 X Slope (%)	N/A

N/A	Ramp inside XWalk1?	N/A	N/A	Ramp inside XWalk2?	N/A
	Road Slope (%)	N/A	N/A	Clear Space?	N/A
	Road X Slope (%)	N/A	N/A	Clear Space to XWalk (in)	N/A
N/A	Any Obstructions?	N/A	N/A	Storm Grate/Utility Hazard?	N/A
	Obstruction Type			Storm Grate/Utility Type	
		N/A			N/A
			Yes	Surface Condition? (G/P)	Good

**Remove & Replace Entire Ramp.**

**R304.5.1, R304.2.2, R304.5.3**
