Access Compliance Report

Public Rights-of-Way

(Curb Ramps)

Intersection ID: 10036975	Main Street: S_TRYON_ST	Cross Street: N/A	Location: NW
ADA ID: 04A8523F48A8	Ramp Type: Perp	Initial Pass/Fail: Fail	Overall Compliance: No
Severity Score: 46.25			
Codes/Mitigation Info/Possible Solution		Field Measurements/Component Compliance

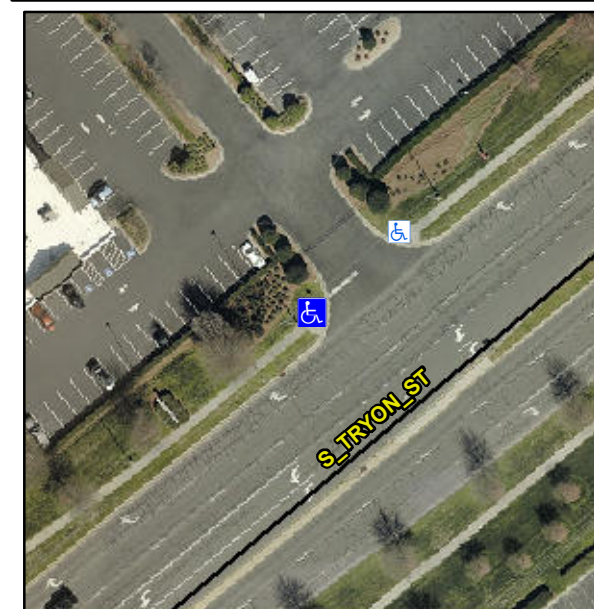
R304.5.1, R304.2.2, R304.5.3

Compliance	Description	Data	Compliance	Description	Data
N/A	Ramp Length (in)	101.0	No	Ramp Slope (%)	8.7
No	Ramp Width (in)	47.0	No	Ramp XSlope (%)	9.1
N/A	Flare Type LT	N/A	N/A	Flare Type RT	N/A
N/A	Flare Slope LT (%)	N/A	N/A	Flare Slope RT (%)	N/A
N/A	Flare Traversable LT?	N/A	N/A	Flare Traversable RT?	N/A
N/A	Landing Length (in)	N/A	N/A	DWS Provided?	N/A
N/A	Landing Width (in)	N/A	N/A	DWS Contrast?	N/A
N/A	Landing Slope (%)	N/A	N/A	DWS Length (in)	N/A
N/A	Landing X Slope (%)	N/A	N/A	DWS Full Width?	N/A
N/A	Landing Curb? (Y/N)	N/A	N/A	DWS Offset (in)	N/A
N/A	Shared Landing?	N/A			
N/A	Gutter Ponding?	N/A	N/A	Gutter Slope (%)	N/A
N/A	Gutter Lip Ht (in)	N/A	N/A	Gutter X Slope (%)	N/A
N/A	Painted X Walk1?	No	N/A	Painted X Walk2?	N/A
	X Walk 1 Direction	To E		X Walk 2 Direction	N/A
N/A	X Walk 1 Width (in)	N/A	N/A	X Walk 2 Width (in)	N/A
	X Walk 1 Slope (%)	4.3		X Walk 2 Slope (%)	N/A
	X Walk 1 X Slope (%)	2.0		X Walk 2 X Slope (%)	N/A

Remove & Replace Entire Ramp.
