# Access Compliance Report

## Public Rights-of-Way

### (Curb Ramps)

| Intersection ID: 21016 | Main Street: COVEDALE_DR | Cross Street: WISHING_WELL_LN | Location: NW |

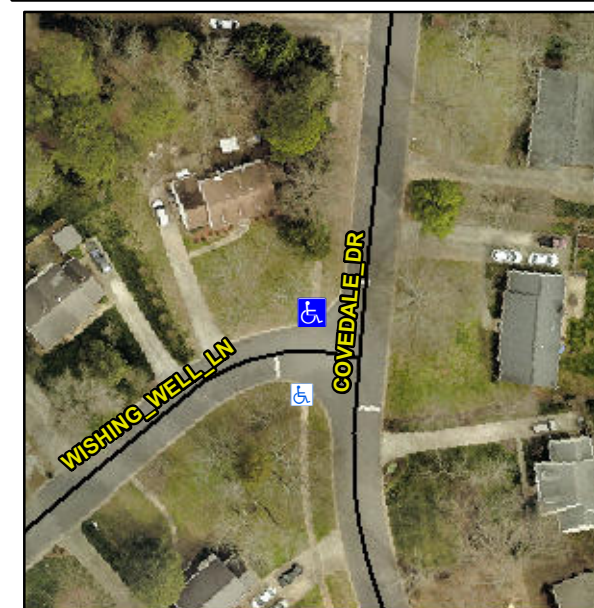
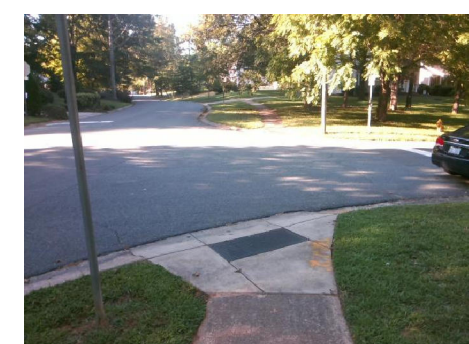
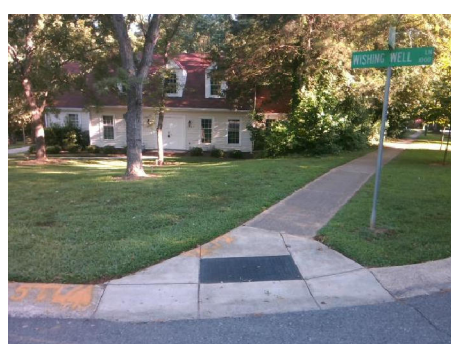
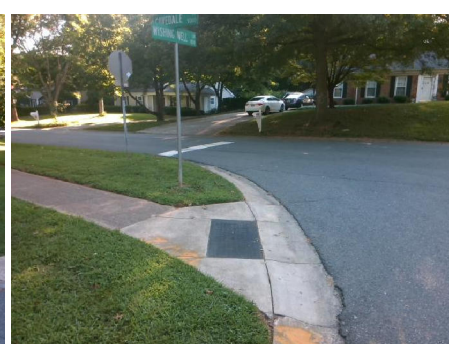
| ADA ID: 04AA058D0BC3 | Ramp Type: PerpDiag | Initial Pass/Fail: Fail | Overall Compliance: No |

**Not Found, R304.5.3**

| Compliance | Description | Data | Compliance | Description | Data |
|---|---|---|---|---|---|
| N/A | Ramp Length (in) | 40.0 | Yes | Ramp Slope (%) | 5.5 |
| Yes | Ramp Width (in) | 48.0 | No | Ramp XSlope (%) | 2.6 |

**Remove & Replace Curb Ramp With Two New Directional Ramps or Equivalent.**

Total Cost: \$ 3200.00
