Access Compliance Report

Public Rights-of-Way

(Curb Ramps)

Intersection ID: 45169	Main Street: HAZELVIEW_DR	Cross Street: LINDEN_TREE_LN	Location: NW
ADA ID: 04B159BF493F	Ramp Type: PerpDiag	Initial Pass/Fail: Fail	Overall Compliance: No
Severity Score: 33.75			
Codes/Mitigation Info/Possible Solution		Field Measurements/Component Compliance

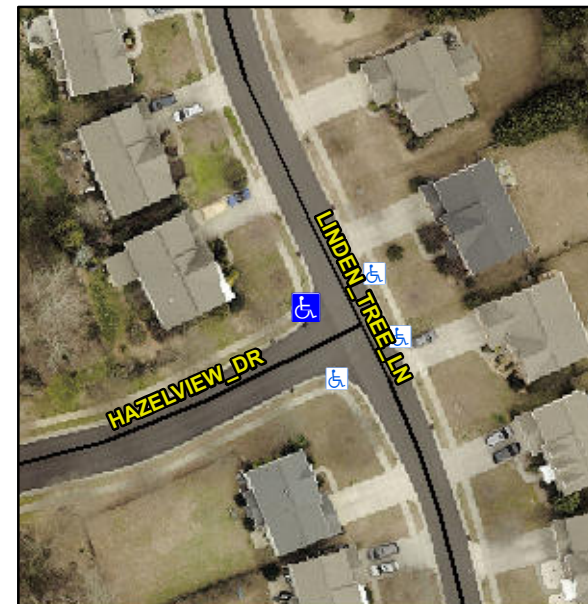
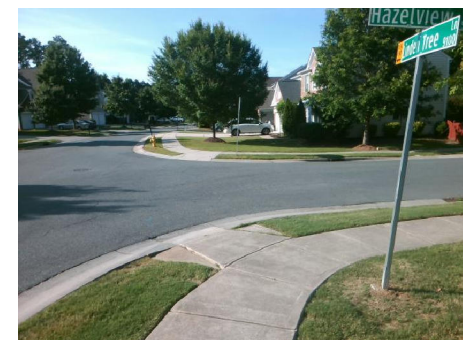
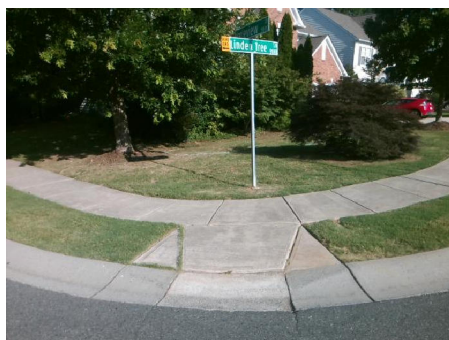
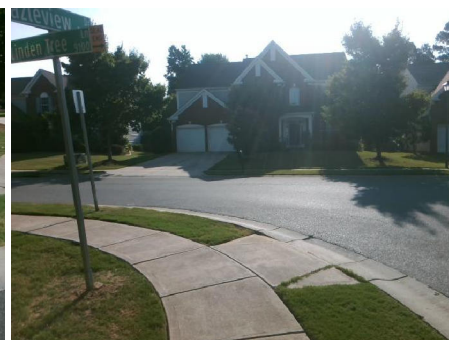
Not Found, R304.5.1, R304.5.3

Compliance	Description	Data	Compliance	Description	Data
N/A	Ramp Length (in)	47.0	Yes	Ramp Slope (%)	6.0
No	Ramp Width (in)	44.0	No	Ramp XSlope (%)	8.3
N/A	Flare Type LT	N/A	N/A	Flare Type RT	N/A
N/A	Flare Slope LT (%)	N/A	N/A	Flare Slope RT (%)	N/A
N/A	Flare Traversable LT?	N/A	N/A	Flare Traversable RT?	N/A
N/A	Landing Length (in)	N/A	N/A	DWS Provided?	N/A
N/A	Landing Width (in)	N/A	N/A	DWS Contrast?	N/A
N/A	Landing Slope (%)	N/A	N/A	DWS Length (in)	N/A
N/A	Landing X Slope (%)	N/A	N/A	DWS Full Width?	N/A
N/A	Landing Curb? (Y/N)	N/A	N/A	DWS Offset (in)	N/A
N/A	Shared Landing?	N/A			
N/A	Gutter Ponding?	N/A	N/A	Gutter Slope (%)	N/A
N/A	Gutter Lip Ht (in)	N/A	N/A	Gutter X Slope (%)	N/A
N/A	Painted X Walk1?	No	N/A	Painted X Walk2?	No
	X Walk 1 Direction	To S		X Walk 2 Direction	To E
N/A	X Walk 1 Width (in)	N/A	N/A	X Walk 2 Width (in)	N/A
	X Walk 1 Slope (%)	1.8		X Walk 2 Slope (%)	5.1
	X Walk 1 X Slope (%)	6.1		X Walk 2 X Slope (%)	0.7

N/A	Ramp inside XWalk1?	N/A	N/A	Ramp inside XWalk2?	N/A
	Road Slope (%)	4.3	N/A	Clear Space?	N/A
	Road X Slope (%)	4.8	N/A	Clear Space to XWalk (in)	N/A
N/A	Any Obstructions?	N/A	N/A	Storm Grate/Utility Hazard?	N/A
	Obstruction Type			Storm Grate/Utility Type	
		N/A			N/A
			Yes	Surface Condition? (G/P)	Good

Remove & Replace Curb Ramp With Two New Directional Ramps or Equivalent.

Total Cost: \$ 3200.00
