Access Compliance Report Public Rights-of-Way (Curb Ramps)

Intersection ID: 9255 Main Street: BOOKER_AV Cross Street: CAMPUS_ST Location: NW
ADA ID: 04B271579CC9 Ramp Type: BlendTrans1 Initial Pass/Fail: Fail Overall Compliance: No Severity Score: 36.25

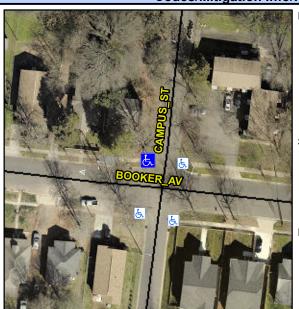
PROW/ADA:
Not Found, R304.5.1, R304.5.3

Compliance Description Data Compliance Description Data Yes BlendTrans Slope (%) N/A Ramp Length (in) 61.0 0.3 No No Ramp Width (in) 30.0 BlendTrans XSlope (%) 4.4 N/A N/A Flare Type LT N/A Flare Type RT N/A N/A Flare Slope LT (%) N/A N/A Flare Slope RT (%) N/A N/A Flare Traversable LT? N/A N/A Flare Traversable RT? N/A N/A Landing Length (in) N/A N/A DWS Provided? N/A N/A Landing Width (in) N/A N/A **DWS Contrast?** N/A N/A N/A N/A Landing Slope (%) DWS Length (in) N/A N/A Landing X Slope (%) N/A N/A DWS Full Width? N/A N/A Landing Curb? (Y/N) N/A N/A DWS Offset (in) N/A N/A N/A Shared Landing? N/A **Gutter Ponding?** N/A N/A Gutter Slope (%) N/A N/A Gutter Lip Ht (in) N/A N/A Gutter X Slope (%) N/A N/A Painted X Walk1? No N/A Painted X Walk2? No X Walk 1 Direction To S X Walk 2 Direction To E N/A X Walk 1 Width (in) X Walk 2 Width (in) N/A X Walk 1 Slope (%) 8.2 X Walk 2 Slope (%) 3.3 X Walk 1 X Slope (%) 8.0 X Walk 2 X Slope (%) 3.3 N/A N/A Ramp inside XWalk2? N/A N/A Ramp inside XWalk1? Road Slope (%) 1.9 Clear Space? N/A Road X Slope (%) 2.2 N/A Clear Space to XWalk (in) N/A N/A N/A N/A Any Obstructions? Storm Grate/Utility Hazard? N/A **Obstruction Type** Storm Grate/Utility Type N/A N/A Yes Surface Condition? (G/P) Good No 17.0 Curb Slope (%)

Possible Solutions:

Remove & Replace Curb Ramp With
Two New Directional Ramps or
Equivalent.
