Access Compliance Report

Public Rights-of-Way

(Curb Ramps)

Intersection ID: 4155	Main Street: ANDREW_JAMES_DR	Cross Street: OVERLOOK_MOUNTAIN_DR	Location: NE
ADA ID: 04B849EE1F8A	Ramp Type: Perp	Initial Pass/Fail: Fail	Overall Compliance: No
Severity Score: 12.5			
Codes/Mitigation Info/Possible Solution		Field Measurements/Component Compliance

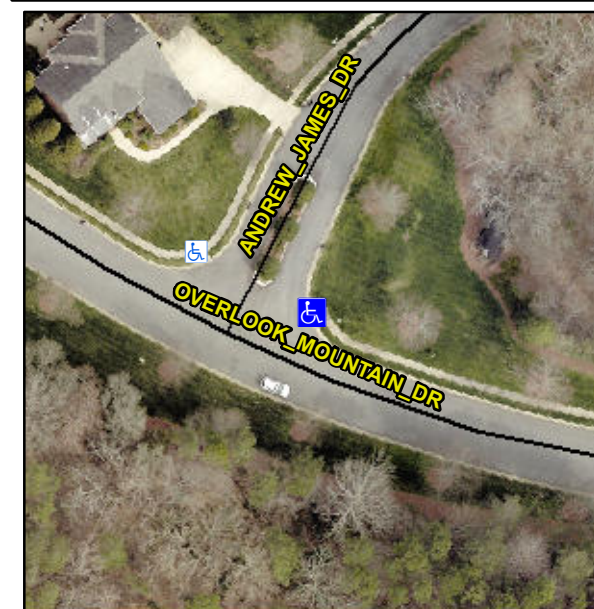
Not Found, R304.2.2

Compliance	Description	Data	Compliance	Description	Data
N/A	Ramp Length (in)	47.0	No	Ramp Slope (%)	8.9
Yes	Ramp Width (in)	48.0	Yes	Ramp XSlope (%)	2.0
N/A	Flare Type LT	N/A	N/A	Flare Type RT	N/A
N/A	Flare Slope LT (%)	N/A	N/A	Flare Slope RT (%)	N/A
N/A	Flare Traversable LT?	N/A	N/A	Flare Traversable RT?	N/A
N/A	Landing Length (in)	N/A	N/A	DWS Provided?	N/A
N/A	Landing Width (in)	N/A	N/A	DWS Contrast?	N/A
N/A	Landing Slope (%)	N/A	N/A	DWS Length (in)	N/A
N/A	Landing X Slope (%)	N/A	N/A	DWS Full Width?	N/A
N/A	Landing Curb? (Y/N)	N/A	N/A	DWS Offset (in)	N/A
N/A	Shared Landing?	N/A			
N/A	Gutter Ponding?	N/A	N/A	Gutter Slope (%)	N/A
N/A	Gutter Lip Ht (in)	N/A	N/A	Gutter X Slope (%)	N/A
N/A	Painted X Walk1?	No	N/A	Painted X Walk2?	N/A
	X Walk 1 Direction	To NW		X Walk 2 Direction	N/A
N/A	X Walk 1 Width (in)	N/A	N/A	X Walk 2 Width (in)	N/A
	X Walk 1 Slope (%)	0.6		X Walk 2 Slope (%)	N/A
	X Walk 1 X Slope (%)	0.2		X Walk 2 X Slope (%)	N/A

N/A	Ramp inside XWalk1?	N/A	N/A	Ramp inside XWalk2?	N/A
	Road Slope (%)	N/A	N/A	Clear Space?	N/A
	Road X Slope (%)	N/A	N/A	Clear Space to XWalk (in)	N/A
N/A	Any Obstructions?	N/A	N/A	Storm Grate/Utility Hazard?	N/A
	Obstruction Type			Storm Grate/Utility Type	
		N/A			N/A
			Yes	Surface Condition? (G/P)	Good

Remove & Replace Entire Ramp.
