# Access Compliance Report

## Public Rights-of-Way

Intersection ID: 25436	Main Street: ROLLING_SKY_DR	Cross Street: SOUTHBRIDGE_FOREST_DR	Location: NW
ADA ID: 04C81CB19E45	Ramp Type: PerpDiag	Initial Pass/Fail: Fail	Overall Compliance: No
Codes/Mitigation Info/Possible Solution		Field Measurements/Component Compliance	
Severity Score: 13.75

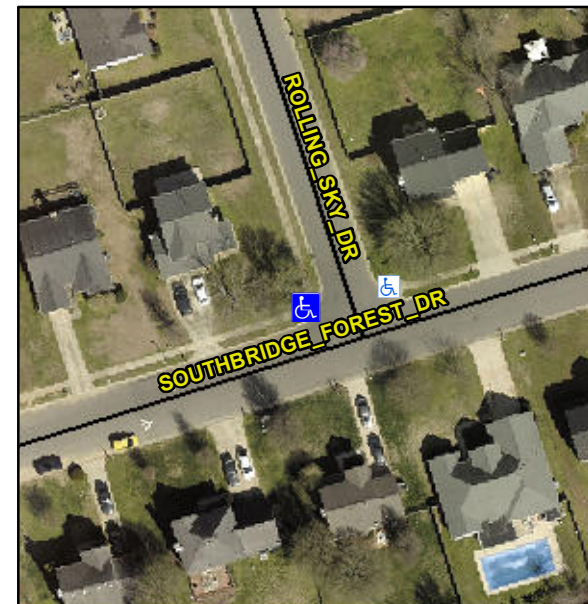
**Not Found, R304.2.2, R304.5.3**

Compliance	Description	Data	Compliance	Description	Data
N/A	Ramp Length (in)	50.0	No	Ramp Slope (%)	8.9
Yes	Ramp Width (in)	48.0	No	Ramp XSlope (%)	2.3
N/A	Flare Type LT	N/A	N/A	Flare Type RT	N/A
N/A	Flare Slope LT (%)	N/A	N/A	Flare Slope RT (%)	N/A
N/A	Flare Traversable LT?	N/A	N/A	Flare Traversable RT?	N/A
N/A	Landing Length (in)	N/A	N/A	DWS Provided?	N/A
N/A	Landing Width (in)	N/A	N/A	DWS Contrast?	N/A
N/A	Landing Slope (%)	N/A	N/A	DWS Length (in)	N/A
N/A	Landing X Slope (%)	N/A	N/A	DWS Full Width?	N/A
N/A	Landing Curb? (Y/N)	N/A	N/A	DWS Offset (in)	N/A
N/A	Shared Landing?	N/A			
N/A	Gutter Ponding?	N/A	N/A	Gutter Slope (%)	N/A
N/A	Gutter Lip Ht (in)	N/A	N/A	Gutter X Slope (%)	N/A
N/A	Painted X Walk1?	No	N/A	Painted X Walk2?	No
	X Walk 1 Direction	To S		X Walk 2 Direction	To E
N/A	X Walk 1 Width (in)	N/A	N/A	X Walk 2 Width (in)	N/A
	X Walk 1 Slope (%)	4.5		X Walk 2 Slope (%)	1.8
	X Walk 1 X Slope (%)	2.1		X Walk 2 X Slope (%)	0.1

N/A	Ramp inside XWalk1?	N/A	N/A	Ramp inside XWalk2?	N/A
	Road Slope (%)	0.0	N/A	Clear Space?	N/A
	Road X Slope (%)	0.6	N/A	Clear Space to XWalk (in)	N/A
N/A	Any Obstructions?	N/A	N/A	Storm Grate/Utility Hazard?	N/A
	Obstruction Type			Storm Grate/Utility Type	
		N/A			N/A
			Yes	Surface Condition? (G/P)	Good

**Remove & Replace Curb Ramp With Two New Directional Ramps or Equivalent.**
