## **Access Compliance Report Public Rights-of-Way** (Curb Ramps)

Intersection ID: 10037294 Main Street: SARDIS RD **Cross Street: N/A** Location: W Initial Pass/Fail: Fail **ADA ID: 04C9ED4EB325** Ramp Type: PerpDiag **Overall Compliance: No Severity Score:** 8.75

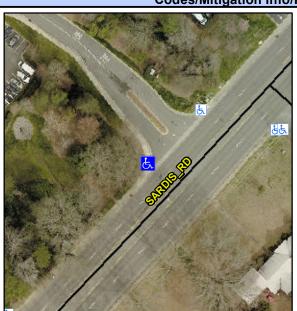
Field Measurements/Component Compliance					
Compliance Description		Data	Comp	oliance Description	Data
N/A	Ramp Length (in)	60.0	Yes	Ramp Slope (%)	6.0
No	Ramp Width (in)	47.5	Yes	Ramp XSlope (%)	1.3
N/A	Flare Type LT	N/A	N/A	Flare Type RT	N/A
N/A	Flare Slope LT (%)	N/A	N/A	Flare Slope RT (%)	N/A
N/A	Flare Traversable LT?	N/A	N/A	Flare Traversable RT?	N/A
N/A	Landing Length (in)	N/A	N/A	DWS Provided?	N/A
N/A	Landing Width (in)	N/A	N/A	DWS Contrast?	N/A
N/A	Landing Slope (%)	N/A	N/A	DWS Length (in)	N/A
N/A	Landing X Slope (%)	N/A	N/A	DWS Full Width?	N/A
N/A	Landing Curb? (Y/N)	N/A	N/A	DWS Offset (in)	N/A
N/A	Shared Landing?	N/A			
N/A	Gutter Ponding?	N/A	N/A	Gutter Slope (%)	N/A
N/A	Gutter Lip Ht (in)	N/A	N/A	Gutter X Slope (%)	N/A
N/A	Painted X Walk1?	No	N/A	Painted X Walk2?	No
	X Walk 1 Direction	To SE		X Walk 2 Direction	To NE
N/A	X Walk 1 Width (in)	N/A	N/A	X Walk 2 Width (in)	N/A
	X Walk 1 Slope (%)	1.6		X Walk 2 Slope (%)	3.7

X Walk 1 X Slope (%)	1.7		X Walk 2 X Slope (%)	3.3
N/A	Ramp inside XWalk1?	N/A	N/A	Ramp inside XWalk2?	N/A
	Road Slope (%)	0.7	N/A	Clear Space?	N/A
	Road X Slope (%)	2.7	N/A	Clear Space to XWalk (in)	N/A
N/A	Any Obstructions?	N/A	N/A	Storm Grate/Utility Hazard?	N/A
	Obstruction Type			Storm Grate/Utility Type	
		N/A			N/A
			Yes	Surface Condition? (G/P)	Good
<b>"好"</b> "我们们的"一个"

Possible Solutions: Remove & Replace Curb Ramp With Two New Directional Ramps or Equivalent. Surveyor Notes: N/A PROW/ADA: R304.5.1

Total Cost: 3200.00
