Access Compliance Report

Public Rights-of-Way (Curb Ramps)

Intersection ID: 17513	Main Street: PROVIDENCE_DR	Cross Street: PROVIDENCE_RD	Location: SE
ADA ID: 04CA27731D25	Ramp Type: Directional1	Initial Pass/Fail: Fail	Overall Compliance: No
Codes/Mitigation Info/Possible Solution		Field Measurements/Component Compliance	
Severity Score: 26.25

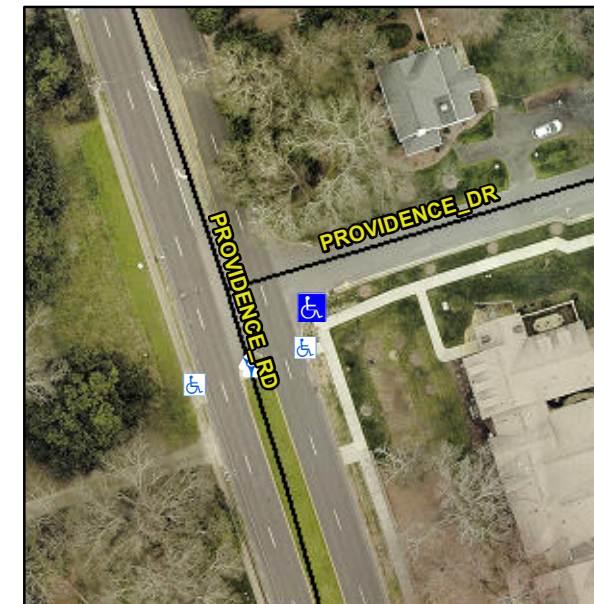
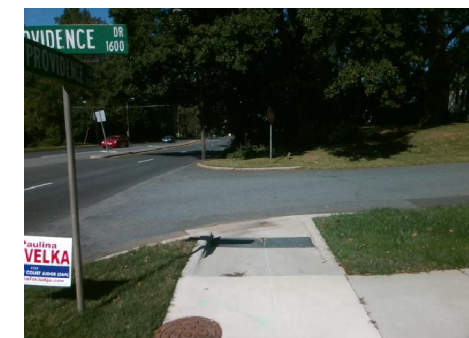
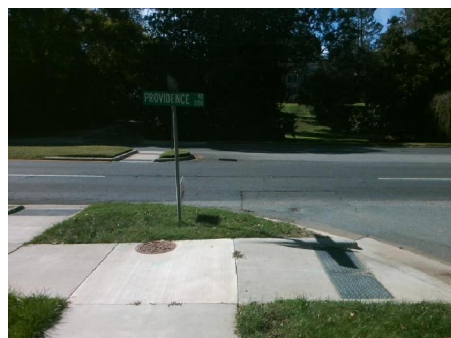
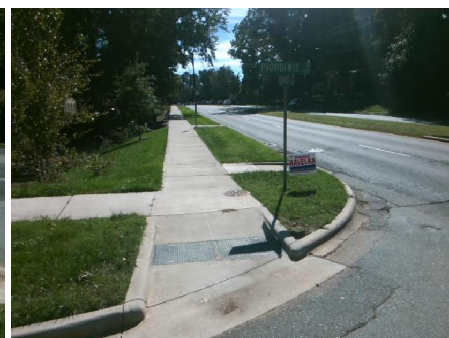
Compliance	Description	Data	Compliance	Description	Data
N/A	Ramp Length (in)	73.0	N/A	Grade Break?	N/A
Yes	Ramp Width (in)	68.0	N/A	Grade Break Slope (%)	0.0
No	Ramp Slope (%)	12.0	N/A	Grade Break XSlope (%)	0.0
No	Ramp XSlope (%)	4.6			
N/A	Flare Type LT	N/A	N/A	Flare Type RT	N/A
N/A	Flare Slope LT (%)	N/A	N/A	Flare Slope RT (%)	0.0
N/A	Flare Traversable LT?	N/A	N/A	Flare Traversable RT?	N/A
N/A	Landing Length (in)	0.0	N/A	DWS Provided?	N/A
N/A	Landing Width (in)	0.0	N/A	DWS Contrast?	N/A
N/A	Landing Slope (%)	0.0	N/A	DWS Length (in)	N/A
N/A	Landing X Slope (%)	0.0	N/A	DWS Full Width?	N/A
N/A	Landing Curb? (Y/N)	N/A	N/A	DWS Offset LT (in)	N/A
N/A	Shared Landing?	N/A	N/A	DWS Offset RT (in)	N/A
N/A	Gutter Ponding?	0.0	N/A	Gutter Slope (%)	N/A
N/A	Gutter Lip Ht (in)	0.0	N/A	Gutter X Slope (%)	N/A
N/A	Painted X Walk1?	No		Road Slope (%)	1.7
	X Walk 1 Direction	To NW		Road X Slope (%)	1.0
	X Walk 1 Width (in)	N/A		Clear Space?	N/A

X Walk 1 Slope (%)	1.7	N/A	Clear Space to XWalk (in)	N/A
	X Walk 1 X Slope (%)	1.0	N/A	Storm Grate/Utility Hazard?	N/A
N/A	Ramp inside XWalk1?	N/A		Storm Grate/Utility Type	
N/A	Any Obstructions?	N/A			N/A
	Obstruction Type		Yes	Surface Condition? (G/P)	Good
			N/A	Curb Slope (%)	0.6

Remove & Replace Entire Ramp.
