Access Compliance Report

Public Rights-of-Way

(Curb Ramps)

Intersection ID: 53623	Main Street: JIMMY_OEHLER_RD	Cross Street: OEHLER_BRIDGE_DR	Location: W
ADA ID: 04CCC701015E	Ramp Type: Perp	Initial Pass/Fail: Fail	Overall Compliance: No
		Severity Score: 10

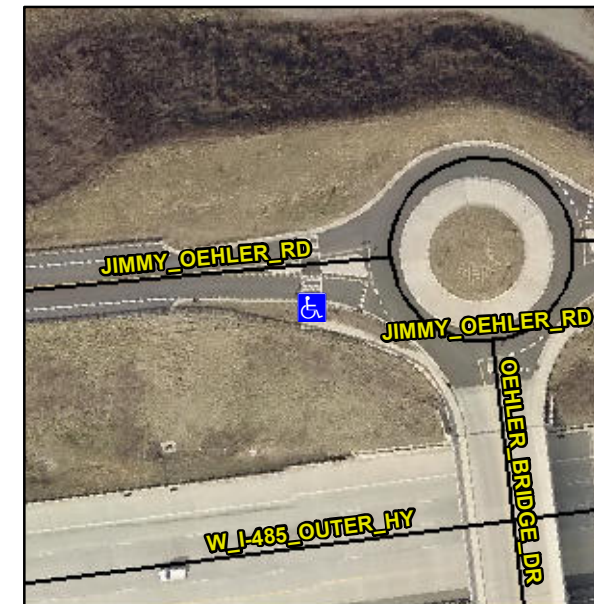
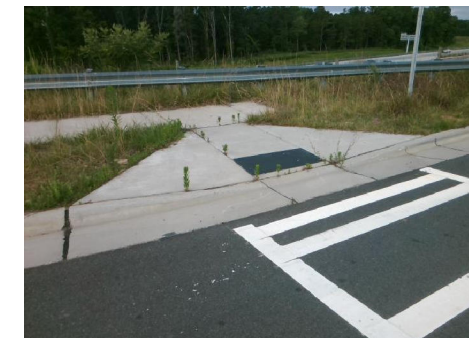
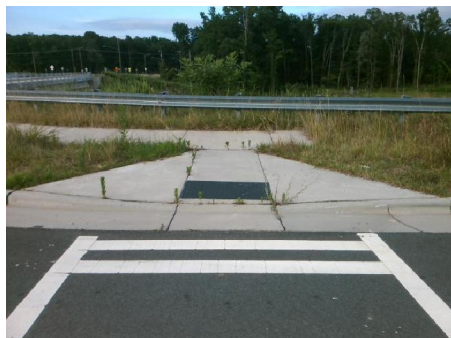
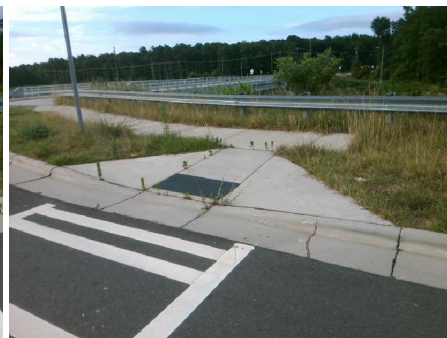
Compliance	Description	Data	Compliance	Description	Data
N/A	Ramp Length (in)	90.0	Yes	Ramp Slope (%)	6.5
No	Ramp Width (in)	44.0	No	Ramp XSlope (%)	3.1
N/A	Flare Type LT	N/A	N/A	Flare Type RT	N/A
N/A	Flare Slope LT (%)	N/A	N/A	Flare Slope RT (%)	N/A
N/A	Flare Traversable LT?	N/A	N/A	Flare Traversable RT?	N/A
N/A	Landing Length (in)	N/A	N/A	DWS Provided?	N/A
N/A	Landing Width (in)	N/A	N/A	DWS Contrast?	N/A
N/A	Landing Slope (%)	N/A	N/A	DWS Length (in)	N/A
N/A	Landing X Slope (%)	N/A	N/A	DWS Full Width?	N/A
N/A	Landing Curb? (Y/N)	N/A	N/A	DWS Offset (in)	N/A
N/A	Shared Landing?	N/A			
N/A	Gutter Ponding?	N/A	N/A	Gutter Slope (%)	N/A
N/A	Gutter Lip Ht (in)	N/A	N/A	Gutter X Slope (%)	N/A
N/A	Painted X Walk1?	Yes	N/A	Painted X Walk2?	N/A
	X Walk 1 Direction	To N		X Walk 2 Direction	N/A
N/A	X Walk 1 Width (in)	105.0	N/A	X Walk 2 Width (in)	N/A
	X Walk 1 Slope (%)	3.6		X Walk 2 Slope (%)	N/A
	X Walk 1 X Slope (%)	1.4		X Walk 2 X Slope (%)	N/A

N/A	Ramp inside XWalk1?	Yes	N/A	Ramp inside XWalk2?	N/A
	Road Slope (%)	N/A	N/A	Clear Space?	N/A
	Road X Slope (%)	N/A	N/A	Clear Space to XWalk (in)	N/A
N/A	Any Obstructions?	N/A	N/A	Storm Grate/Utility Hazard?	N/A
	Obstruction Type			Storm Grate/Utility Type	
		N/A			N/A
		Yes		Surface Condition? (G/P)	Good

Remove & Replace Entire Ramp.

R304.5.1, R304.5.3
