# Access Compliance Report

## Public Rights-of-Way

### (Curb Ramps)

Intersection ID: 10033070	Main Street: NORTH_COMMUNITY_HOUSE_RD	Cross Street: N/A	Location: NE
ADA ID: 04CCD3B6EA91	Ramp Type: Perp	Initial Pass/Fail: Fail	Overall Compliance: No
Severity Score: 21.25			
Codes/Mitigation Info/Possible Solution		Field Measurements/Component Compliance

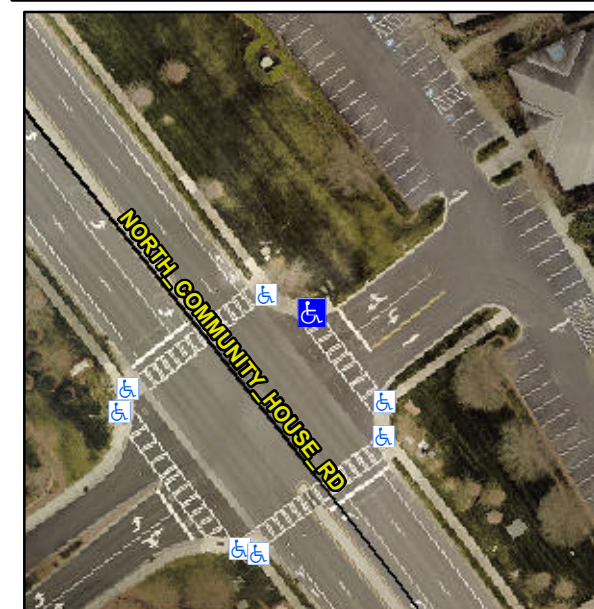
**Not Found, R304.5.1, R304.5.3**

Compliance	Description	Data	Compliance	Description	Data
N/A	Ramp Length (in)	25.5	Yes	Ramp Slope (%)	6.4
No	Ramp Width (in)	47.5	No	Ramp XSlope (%)	5.7
N/A	Flare Type LT	N/A	N/A	Flare Type RT	N/A
N/A	Flare Slope LT (%)	N/A	N/A	Flare Slope RT (%)	N/A
N/A	Flare Traversable LT?	N/A	N/A	Flare Traversable RT?	N/A
N/A	Landing Length (in)	N/A	N/A	DWS Provided?	N/A
N/A	Landing Width (in)	N/A	N/A	DWS Contrast?	N/A
N/A	Landing Slope (%)	N/A	N/A	DWS Length (in)	N/A
N/A	Landing X Slope (%)	N/A	N/A	DWS Full Width?	N/A
N/A	Landing Curb? (Y/N)	N/A	N/A	DWS Offset (in)	N/A
N/A	Shared Landing?	N/A			
N/A	Gutter Ponding?	N/A	N/A	Gutter Slope (%)	N/A
N/A	Gutter Lip Ht (in)	N/A	N/A	Gutter X Slope (%)	N/A
N/A	Painted X Walk1?	Yes	N/A	Painted X Walk2?	N/A
	X Walk 1 Direction	To SE		X Walk 2 Direction	N/A
N/A	X Walk 1 Width (in)	112.0	N/A	X Walk 2 Width (in)	N/A
	X Walk 1 Slope (%)	2.1		X Walk 2 Slope (%)	N/A
	X Walk 1 X Slope (%)	3.7		X Walk 2 X Slope (%)	N/A

N/A	Ramp inside XWalk1?	Yes	N/A	Ramp inside XWalk2?	N/A
	Road Slope (%)	N/A	N/A	Clear Space?	N/A
	Road X Slope (%)	N/A	N/A	Clear Space to XWalk (in)	N/A
N/A	Any Obstructions?	N/A	N/A	Storm Grate/Utility Hazard?	N/A
	Obstruction Type			Storm Grate/Utility Type	
		N/A			N/A
		Yes		Surface Condition? (G/P)	Good

**Remove & Replace Entire Ramp.**
