Access Compliance Report

Public Rights-of-Way (Curb Ramps)

Intersection ID: 52931	Main Street: WALTHAM_LN	Cross Street: GRAY_OAK_LN	Location: S
ADA ID: 04D58CC18650	Ramp Type: Perp	Initial Pass/Fail: Fail	Overall Compliance: No
Severity Score: 21.25			
Codes/Mitigation Info/Possible Solution		Field Measurements/Component Compliance

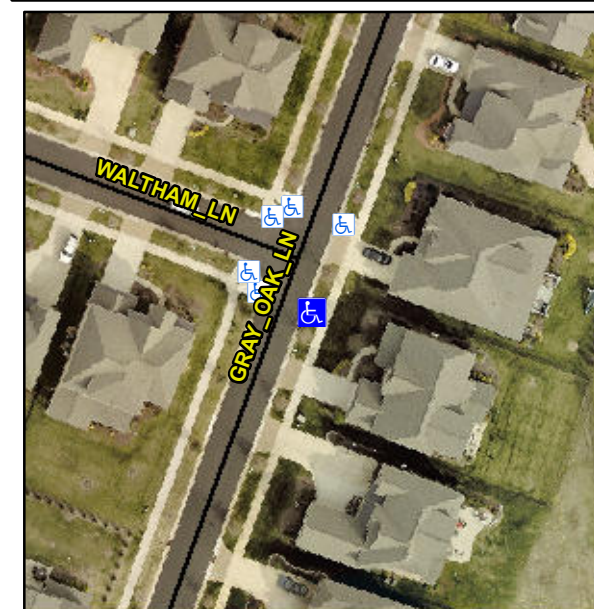
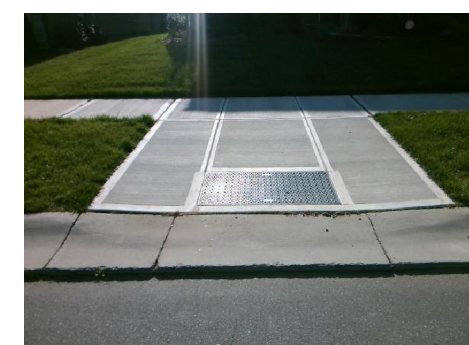
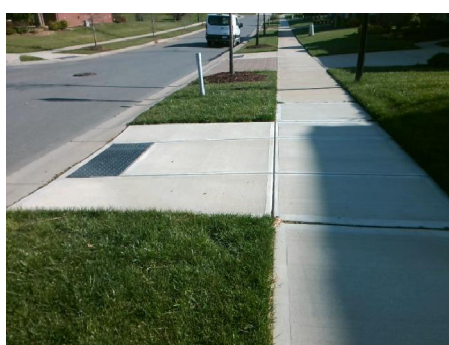
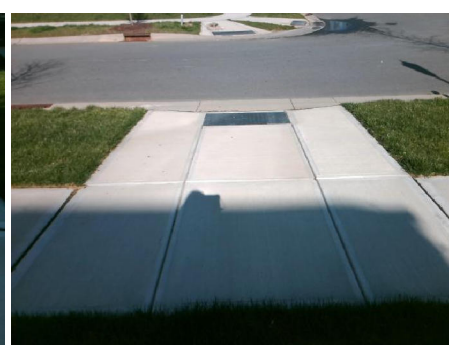
Compliance	Description	Data	Compliance	Description	Data
N/A	Ramp Length (in)	95.0	No	Ramp Slope (%)	8.8
No	Ramp Width (in)	47.5	Yes	Ramp XSlope (%)	1.3
N/A	Flare Type LT	N/A	N/A	Flare Type RT	N/A
N/A	Flare Slope LT (%)	N/A	N/A	Flare Slope RT (%)	N/A
N/A	Flare Traversable LT?	N/A	N/A	Flare Traversable RT?	N/A
N/A	Landing Length (in)	N/A	N/A	DWS Provided?	N/A
N/A	Landing Width (in)	N/A	N/A	DWS Contrast?	N/A
N/A	Landing Slope (%)	N/A	N/A	DWS Length (in)	N/A
N/A	Landing X Slope (%)	N/A	N/A	DWS Full Width?	N/A
N/A	Landing Curb? (Y/N)	N/A	N/A	DWS Offset (in)	N/A
N/A	Shared Landing?	N/A			
N/A	Gutter Ponding?	N/A	N/A	Gutter Slope (%)	N/A
N/A	Gutter Lip Ht (in)	N/A	N/A	Gutter X Slope (%)	N/A
N/A	Painted X Walk1?	No	N/A	Painted X Walk2?	N/A
	X Walk 1 Direction	To NW		X Walk 2 Direction	N/A
N/A	X Walk 1 Width (in)	N/A	N/A	X Walk 2 Width (in)	N/A
	X Walk 1 Slope (%)	3.6		X Walk 2 Slope (%)	N/A
	X Walk 1 X Slope (%)	1.9		X Walk 2 X Slope (%)	N/A

N/A	Ramp inside XWalk1?	N/A	N/A	Ramp inside XWalk2?	N/A
	Road Slope (%)	N/A	N/A	Clear Space?	N/A
	Road X Slope (%)	N/A	N/A	Clear Space to XWalk (in)	N/A
N/A	Any Obstructions?	N/A	N/A	Storm Grate/Utility Hazard?	N/A
	Obstruction Type			Storm Grate/Utility Type	
		N/A			N/A
			Yes	Surface Condition? (G/P)	Good

Remove & Replace Entire Ramp.

R304.5.1, R304.2.2
