Access Compliance Report Public Rights-of-Way (Curb Ramps)

Intersection ID: 50706Main Street:GENERATIONS_STCross Street:BROTHERLY_LNLocation:NEADA ID: 04E0204C64CCRamp Type:PerpDiagInitial Pass/Fail:FailOverall Compliance:NoSeverity Score:25

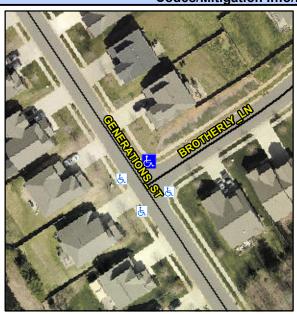
PROW/ADA:
Not Found, R304.5.3

Comp	oliance	Description	Data	Comp	oliance	Description	Data
N/A	Ramp	Length (in)	50.0		Ramp	Slope (%)	6.8
Yes	es Ramp Width (in)		48.0	No	Ram	XSlope (%)	7.5
N/A	Flare	Type LT	N/A	N/A	Flare	Type RT	N/A
N/A	Flare	Slope LT (%)	N/A	N/A	Flare	Slope RT (%)	N/A
N/A	Flare	Traversable LT?	N/A	N/A	Flare	Traversable RT?	N/A
N/A	Landi	ng Length (in)	N/A	N/A	DWS	Provided?	N/A
N/A	Landi	ng Width (in)	N/A	N/A	DWS	Contrast?	N/A
N/A	Landi	ng Slope (%)	N/A	N/A	DWS	Length (in)	N/A
N/A	Landi	ng X Slope (%)	N/A	N/A	DWS	Full Width?	N/A
N/A	Landi	ng Curb? (Y/N)	N/A	N/A	DWS	Offset (in)	N/A
N/A	Share	ed Landing?	N/A				
N/A	Gutte	er Ponding?	N/A	N/A	Gutte	er Slope (%)	N/A
N/A	Gutte	r Lip Ht (in)	N/A	N/A	Gutte	er X Slope (%)	N/A
N/A	Paint	ed X Walk1?	No	N/A	Paint	ed X Walk2?	No
	X Wa	lk 1 Direction	To SE		X Wa	lk 2 Direction	To SW
N/A	X Wa	lk 1 Width (in)	N/A	N/A	X Wa	lk 2 Width (in)	N/A
	X Wa	lk 1 Slope (%)	3.7		X Wa	lk 2 Slope (%)	3.6

X Wa	lk 1 X Slope (%)	6.1		X Wa	lk 2 X Slope (%)	5.5
N/A	Ramp	inside XWalk1?	N/A	N/A	Ram	o inside XWalk2?	N/A
	Road	Slope (%)	7.4	N/A	Clear	Space?	N/A
	Road	X Slope (%)	1.9	N/A	Clear	Space to XWalk (in)	N/A
N/A	Any C	Obstructions?	N/A	N/A	Storn	n Grate/Utility Hazard?	N/A
	Obstr	ruction Type			Storn	n Grate/Utility Type	
			N/A				N/A

Remove & Replace Curb Ramp With
Two New Directional Ramps or
Equivalent.
