## Access Compliance Report Public Rights-of-Way (Curb Ramps)

Intersection ID: 14575 Main Street: HOLLYFIELD\_DR Cross Street: KELSTON\_PL Location: E

ADA ID: 04E15267FBEF Ramp Type: PerpDiag Initial Pass/Fail: Fail Overall Compliance: No Severity Score: 31.25

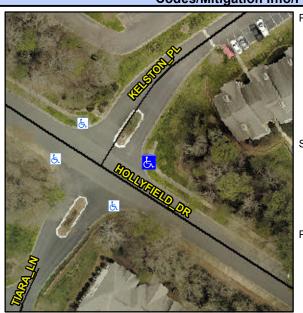
Not Found, R304.5.1, R304.2.2

Compliance Description Data Compliance Description Data No N/A Ramp Length (in) 75.0 Ramp Slope (%) 10.9 Yes Ramp XSlope (%) No Ramp Width (in) 34.0 4.8 N/A N/A Flare Type LT N/A Flare Type RT N/A N/A N/A N/A Flare Slope RT (%) N/A Flare Slope LT (%) N/A Flare Traversable LT? N/A N/A Flare Traversable RT? N/A N/A N/A N/A **DWS Provided?** N/A Landing Length (in) N/A Landing Width (in) N/A N/A **DWS Contrast?** N/A N/A N/A N/A Landing Slope (%) DWS Length (in) N/A N/A Landing X Slope (%) N/A N/A DWS Full Width? N/A N/A Landing Curb? (Y/N) N/A N/A DWS Offset (in) N/A N/A N/A Shared Landing? N/A Gutter Ponding? N/A N/A Gutter Slope (%) N/A N/A Gutter Lip Ht (in) N/A N/A Gutter X Slope (%) N/A N/A Painted X Walk1? No N/A Painted X Walk2? No X Walk 1 Direction To NW X Walk 2 Direction To SW N/A N/A X Walk 1 Width (in) X Walk 2 Width (in) N/A X Walk 1 Slope (%) X Walk 2 Slope (%) 5.9 2.6 X Walk 1 X Slope (%) 4.1 X Walk 2 X Slope (%) 3.7 N/A N/A N/A Ramp inside XWalk2? N/A Ramp inside XWalk1? Road Slope (%) 7.1 N/A Clear Space? N/A N/A Road X Slope (%) 0.8 Clear Space to XWalk (in) N/A

Remove & Replace Curb Ramp With
Two New Directional Ramps or
Equivalent.
