Access Compliance Report Public Rights-of-Way (Curb Ramps)

Intersection ID: 21326 Main Street: PROVIDENCE_RD Cross Street: TURNBRIDGE_RD Location: SW

ADA ID: 04E5FE29DF83 Ramp Type: Directional1 Initial Pass/Fail: Fail Overall Compliance: No Severity Score: 1.25

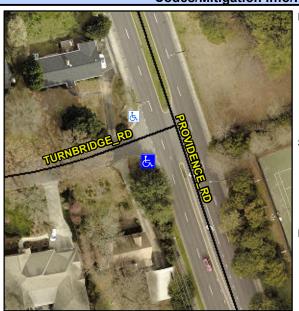
N/A Yes Ramp Slope (%) 5.3 Grade Break XSlope (%) Ramp XSlope (%) 3.1 Flare Type LT N/A N/A Flare Type RT Flare Slope LT (%) N/A N/A Flare Slope RT (%) Flare Traversable LT? N/A N/A Flare Traversable RT? 0.0 N/A **DWS Provided?** Landing Length (in) Landing Width (in) 0.0 N/A **DWS Contrast?** Landing Slope (%) 0.0 N/A DWS Length (in) N/A DWS Full Width? Landing X Slope (%) 0.0 Landing Curb? (Y/N) N/A N/A DWS Offset LT (in) Shared Landing? N/A N/A DWS Offset RT (in) **Gutter Ponding?** 0.0 N/A Gutter Slope (%) Gutter Lip Ht (in) 0.0 N/A Gutter X Slope (%) Painted X Walk1? No Road Slope (%) X Walk 1 Direction To N Road X Slope (%) X Walk 1 Width (in) N/A Clear Space? 0.7 N/A X Walk 1 Slope (%) Clear Space to XWalk (in) X Walk 1 X Slope (%) 1.2 N/A Storm Grate/Utility Hazard? Ramp inside XWalk1? N/A Storm Grate/Utility Type N/A Any Obstructions? **Obstruction Type** Surface Condition? (G/P) Yes N/A N/A Curb Slope (%)

Possible Solutions:

Remove & Replace Entire Ramp.
