# Access Compliance Report

## Public Rights-of-Way

### (Curb Ramps)

Intersection ID: 26100	Main Street: FAIRCHILD_LN	Cross Street: HOLLY_HILL_FARM_RD	Location: NW
ADA ID: 04FF353A89E7	Ramp Type: PerpDiag	Initial Pass/Fail: Fail	Overall Compliance: No
			Severity Score: 13.75

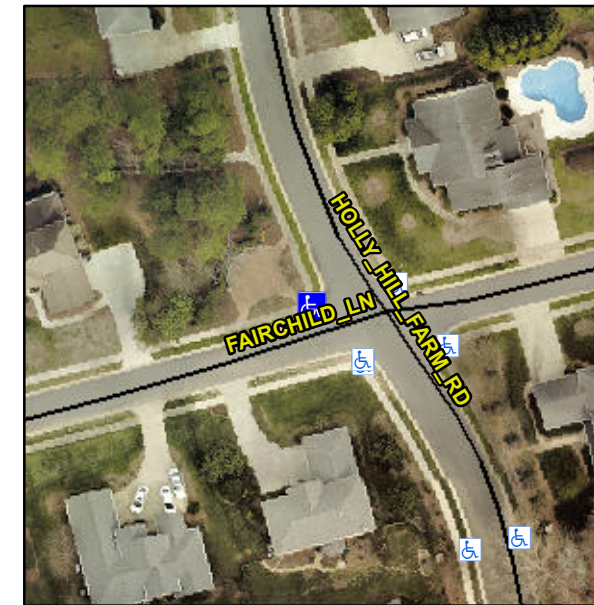
Compliance	Description	Data	Compliance	Description	Data
N/A	Ramp Length (in)	47.0	No	Ramp Slope (%)	8.7
Yes	Ramp Width (in)	48.0	No	Ramp XSlope (%)	2.5
N/A	Flare Type LT	N/A	N/A	Flare Type RT	N/A
N/A	Flare Slope LT (%)	N/A	N/A	Flare Slope RT (%)	N/A
N/A	Flare Traversable LT?	N/A	N/A	Flare Traversable RT?	N/A
N/A	Landing Length (in)	N/A	N/A	DWS Provided?	N/A
N/A	Landing Width (in)	N/A	N/A	DWS Contrast?	N/A
N/A	Landing Slope (%)	N/A	N/A	DWS Length (in)	N/A
N/A	Landing X Slope (%)	N/A	N/A	DWS Full Width?	N/A
N/A	Landing Curb? (Y/N)	N/A	N/A	DWS Offset (in)	N/A
N/A	Shared Landing?	N/A			
N/A	Gutter Ponding?	N/A	N/A	Gutter Slope (%)	N/A
N/A	Gutter Lip Ht (in)	N/A	N/A	Gutter X Slope (%)	N/A
N/A	Painted X Walk1?	No	N/A	Painted X Walk2?	No
	X Walk 1 Direction	To SE		X Walk 2 Direction	To E
N/A	X Walk 1 Width (in)	N/A	N/A	X Walk 2 Width (in)	N/A
	X Walk 1 Slope (%)	4.1		X Walk 2 Slope (%)	3.3
	X Walk 1 X Slope (%)	1.0		X Walk 2 X Slope (%)	3.4

N/A	Ramp inside XWalk1?	N/A	N/A	Ramp inside XWalk2?	N/A
	Road Slope (%)	2.3	N/A	Clear Space?	N/A
	Road X Slope (%)	0.1	N/A	Clear Space to XWalk (in)	N/A
N/A	Any Obstructions?	N/A	N/A	Storm Grate/Utility Hazard?	N/A
	Obstruction Type			Storm Grate/Utility Type	
		N/A			N/A
			Yes	Surface Condition? (G/P)	Good

**Remove & Replace Curb Ramp With Two New Directional Ramps or Equivalent.**
