Access Compliance Report

Public Rights-of-Way

(Curb Ramps)

Intersection ID: 28521	Main Street: LIONSTONE_DR	Cross Street: GARRISON_RD	Location:	N
ADA ID: 050080BC33CE	Ramp Type: Perp	Initial Pass/Fail: Fail	Overall Compliance: No	Severity Score: 21.25
Codes/Mitigation Info/Possible Solution		Field Measurements/Component Compliance

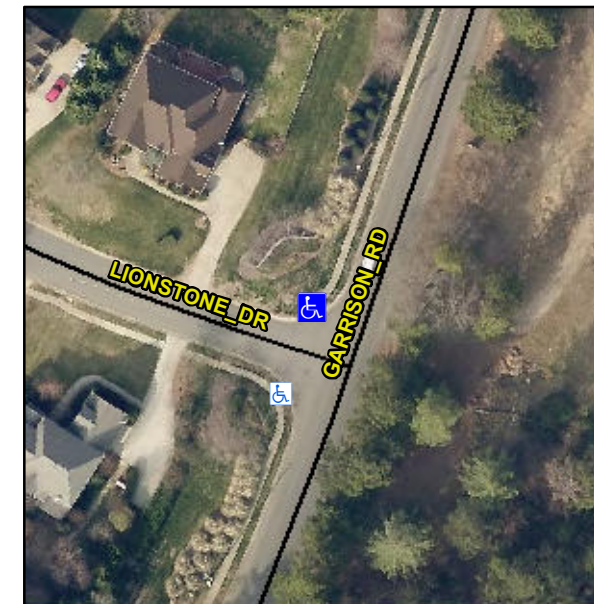
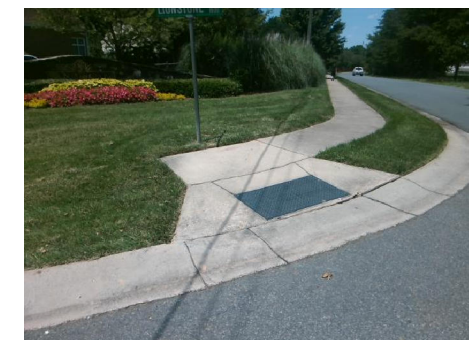
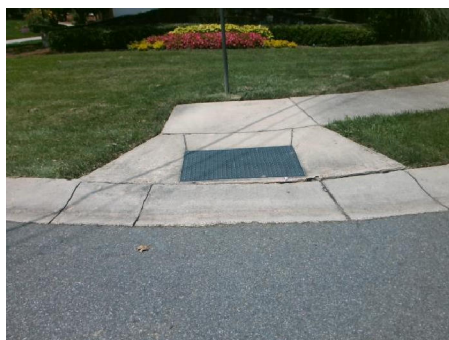
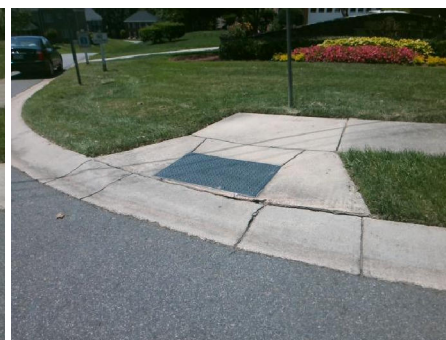
Not Found, R304.5.1, R304.5.3

Compliance	Description	Data	Compliance	Description	Data
N/A	Ramp Length (in)	44.0	Yes	Ramp Slope (%)	5.4
No	Ramp Width (in)	44.0	No	Ramp XSlope (%)	5.9
N/A	Flare Type LT	N/A	N/A	Flare Type RT	N/A
N/A	Flare Slope LT (%)	N/A	N/A	Flare Slope RT (%)	N/A
N/A	Flare Traversable LT?	N/A	N/A	Flare Traversable RT?	N/A
N/A	Landing Length (in)	N/A	N/A	DWS Provided?	N/A
N/A	Landing Width (in)	N/A	N/A	DWS Contrast?	N/A
N/A	Landing Slope (%)	N/A	N/A	DWS Length (in)	N/A
N/A	Landing X Slope (%)	N/A	N/A	DWS Full Width?	N/A
N/A	Landing Curb? (Y/N)	N/A	N/A	DWS Offset (in)	N/A
N/A	Shared Landing?	N/A			
N/A	Gutter Ponding?	N/A	N/A	Gutter Slope (%)	N/A
N/A	Gutter Lip Ht (in)	N/A	N/A	Gutter X Slope (%)	N/A
N/A	Painted X Walk1?	No	N/A	Painted X Walk2?	N/A
	X Walk 1 Direction	To SW		X Walk 2 Direction	N/A
N/A	X Walk 1 Width (in)	N/A	N/A	X Walk 2 Width (in)	N/A
	X Walk 1 Slope (%)	0.7		X Walk 2 Slope (%)	N/A
	X Walk 1 X Slope (%)	2.9		X Walk 2 X Slope (%)	N/A

N/A	Ramp inside XWalk1?	N/A	N/A	Ramp inside XWalk2?	N/A
	Road Slope (%)	N/A	N/A	Clear Space?	N/A
	Road X Slope (%)	N/A	N/A	Clear Space to XWalk (in)	N/A
N/A	Any Obstructions?	N/A	N/A	Storm Grate/Utility Hazard?	N/A
	Obstruction Type			Storm Grate/Utility Type	
		N/A			N/A
			Yes	Surface Condition? (G/P)	Good

Remove & Replace Entire Ramp.
