Access Compliance Report

Public Rights-of-Way

(Curb Ramps)

Intersection ID: 16619	Main Street: PARK_RD	Cross Street: YALE_PL	Location: SE
ADA ID: 0502372EC869	Ramp Type: Perp	Initial Pass/Fail: Pass	Overall Compliance: No
Severity Score: 5.25			
Codes/Mitigation Info/Possible Solution		Field Measurements/Component Compliance

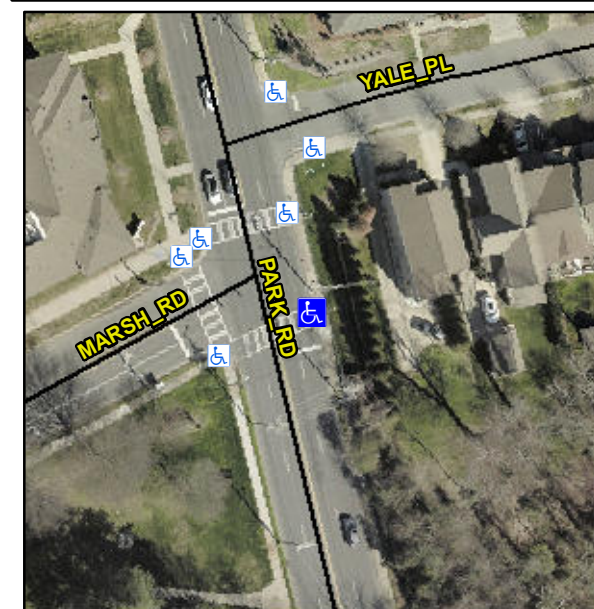
R304.5.4

Compliance	Description	Data	Compliance	Description	Data
N/A	Ramp Length (in)	24.0	Yes	Ramp Slope (%)	6.8
Yes	Ramp Width (in)	48.0	Yes	Ramp XSlope (%)	2.2
N/A	Flare Type LT	Sloped	N/A	Flare Type RT	N/A
N/A	Flare Slope LT (%)	6.2	Yes	Flare Slope RT (%)	3.9
N/A	Flare Traversable LT?	Yes	N/A	Flare Traversable RT?	Yes
Yes	Landing Length (in)	54.0	Yes	DWS Provided?	Yes
Yes	Landing Width (in)	48.0	Yes	DWS Contrast?	Yes
Yes	Landing Slope (%)	0.8	Yes	DWS Length (in)	25.0
Yes	Landing X Slope (%)	0.6	Yes	DWS Full Width?	Yes
N/A	Landing Curb? (Y/N)	No	Yes	DWS Offset (in)	0.0
N/A	Shared Landing?	No			
Yes	Gutter Ponding?	No	No	Gutter Slope (%)	9.7
Yes	Gutter Lip Ht (in)	0.0	Yes	Gutter X Slope (%)	1.1
N/A	Painted X Walk1?	Yes	N/A	Painted X Walk2?	N/A
	X Walk 1 Direction	To SW		X Walk 2 Direction	N/A
N/A	X Walk 1 Width (in)	114.0	N/A	X Walk 2 Width (in)	N/A
	X Walk 1 Slope (%)	4.9		X Walk 2 Slope (%)	N/A
	X Walk 1 X Slope (%)	2.3		X Walk 2 X Slope (%)	N/A

Yes	Ramp inside XWalk1?	Yes	N/A	Ramp inside XWalk2?	N/A
	Road Slope (%)	N/A	N/A	Clear Space?	Yes
	Road X Slope (%)	N/A	N/A	Clear Space to XWalk (in)	N/A
Yes	Any Obstructions?	No	Yes	Storm Grate/Utility Hazard?	No
	Obstruction Type			Storm Grate/Utility Type	
		N/A			N/A
			Yes	Surface Condition? (G/P)	Good

Possible Solutions:

Remove & Replace Gutter.

Total Cost: \$ 750.00
