Access Compliance Report

Public Rights-of-Way

(Curb Ramps)

Intersection ID: 8203	Main Street: HONEYWOOD_AV	Cross Street: TENNESSEE_AV	Location: S
ADA ID: 05127FA3CFA1	Ramp Type: Perp	Initial Pass/Fail: Fail	Overall Compliance: No
Severity Score: 10			
Codes/Mitigation Info/Possible Solution		Field Measurements/Component Compliance

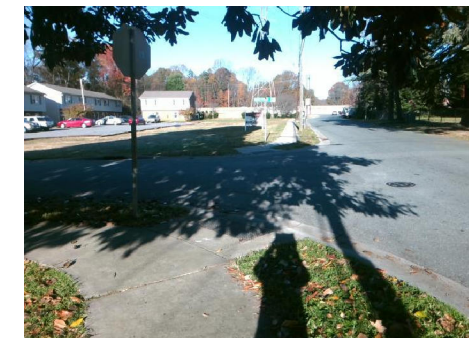
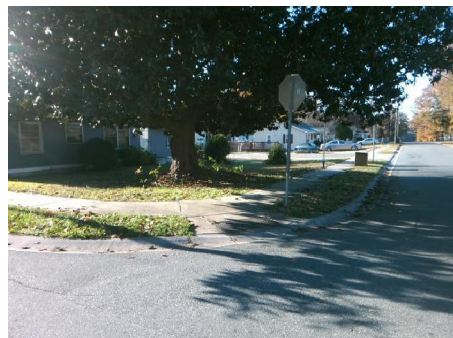
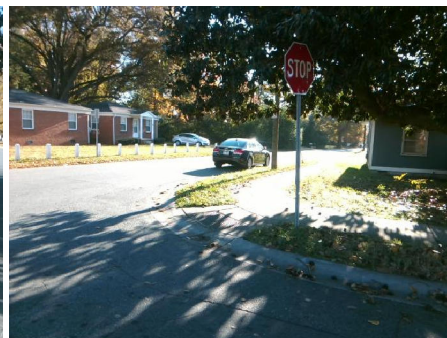
Not Found, R304.5.1, R304.5.3

Compliance	Description	Data	Compliance	Description	Data
N/A	Ramp Length (in)	48.0	Yes	Ramp Slope (%)	6.2
No	Ramp Width (in)	47.5	No	Ramp XSlope (%)	2.6
N/A	Flare Type LT	N/A	N/A	Flare Type RT	N/A
N/A	Flare Slope LT (%)	N/A	N/A	Flare Slope RT (%)	N/A
N/A	Flare Traversable LT?	N/A	N/A	Flare Traversable RT?	N/A
N/A	Landing Length (in)	N/A	N/A	DWS Provided?	N/A
N/A	Landing Width (in)	N/A	N/A	DWS Contrast?	N/A
N/A	Landing Slope (%)	N/A	N/A	DWS Length (in)	N/A
N/A	Landing X Slope (%)	N/A	N/A	DWS Full Width?	N/A
N/A	Landing Curb? (Y/N)	N/A	N/A	DWS Offset (in)	N/A
N/A	Shared Landing?	N/A			
N/A	Gutter Ponding?	N/A	N/A	Gutter Slope (%)	N/A
N/A	Gutter Lip Ht (in)	N/A	N/A	Gutter X Slope (%)	N/A
N/A	Painted X Walk1?	No	N/A	Painted X Walk2?	N/A
	X Walk 1 Direction	To NW		X Walk 2 Direction	N/A
N/A	X Walk 1 Width (in)	N/A	N/A	X Walk 2 Width (in)	N/A
	X Walk 1 Slope (%)	2.1		X Walk 2 Slope (%)	N/A
	X Walk 1 X Slope (%)	0.2		X Walk 2 X Slope (%)	N/A

N/A	Ramp inside XWalk1?	N/A	N/A	Ramp inside XWalk2?	N/A
	Road Slope (%)	N/A	N/A	Clear Space?	N/A
	Road X Slope (%)	N/A	N/A	Clear Space to XWalk (in)	N/A
N/A	Any Obstructions?	N/A	N/A	Storm Grate/Utility Hazard?	N/A
	Obstruction Type			Storm Grate/Utility Type	
		N/A			N/A
		Yes		Surface Condition? (G/P)	Good

Remove & Replace Entire Ramp.
