Access Compliance Report

Public Rights-of-Way

(Curb Ramps)

Intersection ID: 52928	Main Street: GRAY_OAK_LN	Cross Street: MAPLE_OAK_DR	Location: NE
ADA ID: 05151D21D192	Ramp Type: Perp	Initial Pass/Fail: Fail	Overall Compliance: No
Severity Score: 10			
Codes/Mitigation Info/Possible Solution		Field Measurements/Component Compliance

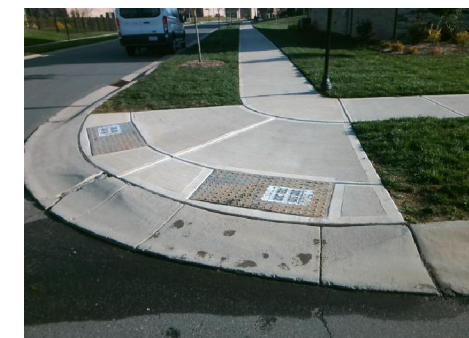
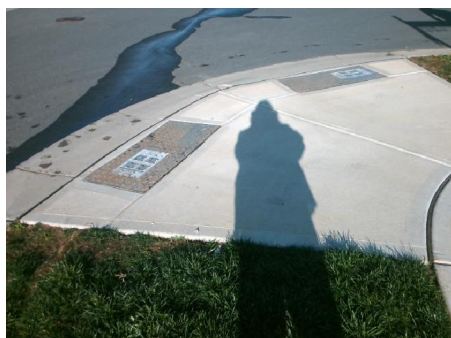
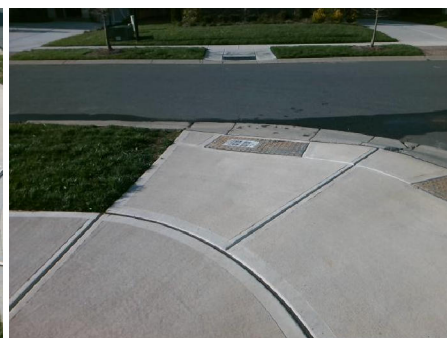
Compliance	Description	Data	Compliance	Description	Data
N/A	Ramp Length (in)	28.0	Yes	Ramp Slope (%)	5.2
No	Ramp Width (in)	45.5	No	Ramp XSlope (%)	3.4
N/A	Flare Type LT	N/A	N/A	Flare Type RT	N/A
N/A	Flare Slope LT (%)	N/A	N/A	Flare Slope RT (%)	N/A
N/A	Flare Traversable LT?	N/A	N/A	Flare Traversable RT?	N/A
N/A	Landing Length (in)	N/A	N/A	DWS Provided?	N/A
N/A	Landing Width (in)	N/A	N/A	DWS Contrast?	N/A
N/A	Landing Slope (%)	N/A	N/A	DWS Length (in)	N/A
N/A	Landing X Slope (%)	N/A	N/A	DWS Full Width?	N/A
N/A	Landing Curb? (Y/N)	N/A	N/A	DWS Offset (in)	N/A
N/A	Shared Landing?	N/A			
N/A	Gutter Ponding?	N/A	N/A	Gutter Slope (%)	N/A
N/A	Gutter Lip Ht (in)	N/A	N/A	Gutter X Slope (%)	N/A
N/A	Painted X Walk1?	No	N/A	Painted X Walk2?	N/A
	X Walk 1 Direction	To S		X Walk 2 Direction	N/A
N/A	X Walk 1 Width (in)	N/A	N/A	X Walk 2 Width (in)	N/A
	X Walk 1 Slope (%)	2.1		X Walk 2 Slope (%)	N/A
	X Walk 1 X Slope (%)	2.9		X Walk 2 X Slope (%)	N/A

N/A	Ramp inside XWalk1?	N/A	N/A	Ramp inside XWalk2?	N/A
	Road Slope (%)	N/A	N/A	Clear Space?	N/A
	Road X Slope (%)	N/A	N/A	Clear Space to XWalk (in)	N/A
N/A	Any Obstructions?	N/A	N/A	Storm Grate/Utility Hazard?	N/A
	Obstruction Type			Storm Grate/Utility Type	
		N/A			N/A
			Yes	Surface Condition? (G/P)	Good

Possible Solutions:

Remove & Replace Entire Ramp.

R304.5.1, R304.5.3
