Access Compliance Report

Public Rights-of-Way

(Curb Ramps)

Intersection ID: 30503	Main Street: SHARON_RD	Cross Street: QUAIL_PARK_DR	Location: NW
ADA ID: 05215D566353	Ramp Type: PerpDiag	Initial Pass/Fail: Fail	Overall Compliance: No
		Severity Score: 10

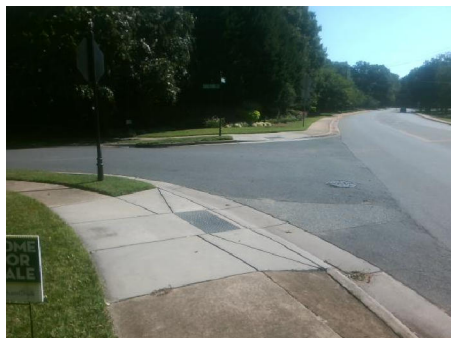
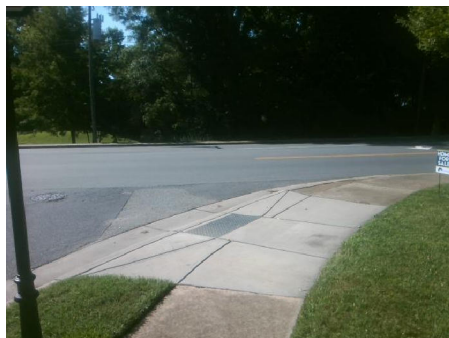
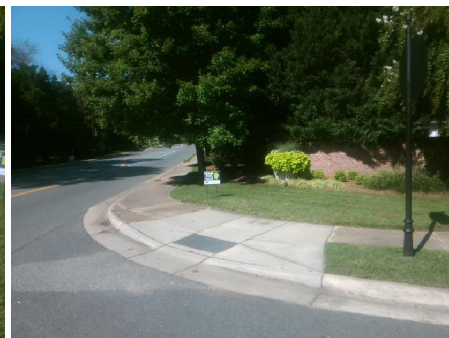
Not Found, R304.5.1, R304.5.3

Compliance	Description	Data	Compliance	Description	Data
N/A	Ramp Length (in)	92.0	Yes	Ramp Slope (%)	6.5
No	Ramp Width (in)	46.5	No	Ramp XSlope (%)	3.3
N/A	Flare Type LT	N/A	N/A	Flare Type RT	N/A
N/A	Flare Slope LT (%)	N/A	N/A	Flare Slope RT (%)	N/A
N/A	Flare Traversable LT?	N/A	N/A	Flare Traversable RT?	N/A
N/A	Landing Length (in)	N/A	N/A	DWS Provided?	N/A
N/A	Landing Width (in)	N/A	N/A	DWS Contrast?	N/A
N/A	Landing Slope (%)	N/A	N/A	DWS Length (in)	N/A
N/A	Landing X Slope (%)	N/A	N/A	DWS Full Width?	N/A
N/A	Landing Curb? (Y/N)	N/A	N/A	DWS Offset (in)	N/A
N/A	Shared Landing?	N/A			
N/A	Gutter Ponding?	N/A	N/A	Gutter Slope (%)	N/A
N/A	Gutter Lip Ht (in)	N/A	N/A	Gutter X Slope (%)	N/A
N/A	Painted X Walk1?	No	N/A	Painted X Walk2?	No
	X Walk 1 Direction	To SE		X Walk 2 Direction	To NE
N/A	X Walk 1 Width (in)	N/A	N/A	X Walk 2 Width (in)	N/A
	X Walk 1 Slope (%)	8.0		X Walk 2 Slope (%)	4.1
	X Walk 1 X Slope (%)	0.1		X Walk 2 X Slope (%)	2.3

N/A	Ramp inside XWalk1?	N/A	N/A	Ramp inside XWalk2?	N/A
	Road Slope (%)	0.1	N/A	Clear Space?	N/A
	Road X Slope (%)	4.3	N/A	Clear Space to XWalk (in)	N/A
N/A	Any Obstructions?	N/A	N/A	Storm Grate/Utility Hazard?	N/A
	Obstruction Type			Storm Grate/Utility Type	
		N/A			N/A
			Yes	Surface Condition? (G/P)	Good

Remove & Replace Curb Ramp With Two New Directional Ramps or Equivalent.
