# Access Compliance Report

## Public Rights-of-Way

| Intersection ID: 14648 | | Main Street: EAST_BV | | Cross Street: LENNOX_AV | | Location: NE | | | |
| ADA ID: 0524964FE81A | | Ramp Type: Directional1 | | Initial Pass/Fail: Fail | | Overall Compliance: No | | Severity Score: 12.5 | |

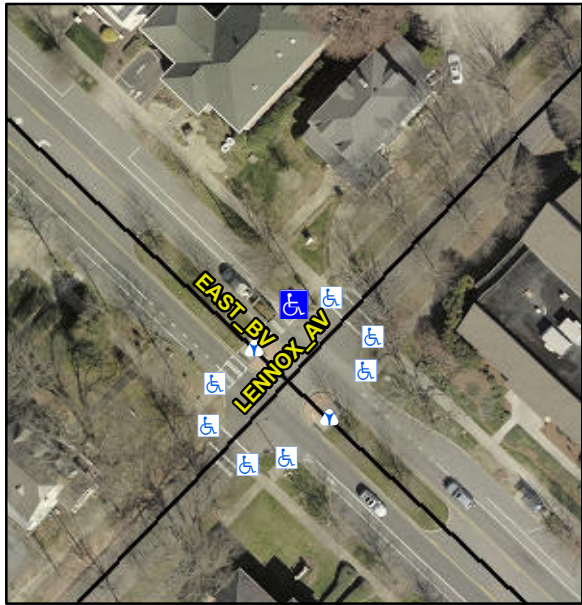
| | | | | No | Ramp Slope (%) | 8.7 | N/A | Grade Break XSlope (%) | 0.0 |

| <div></div> <div>Street 1 NameEAST BV</div> <div>Stop Condition-Street 1None</div> <div>Street 2 NameN/A</div> <div>Stop Condition-Street 2N/A</div> <div>Possible Solutions:<br/><b>Remove &amp; Replace Entire Ramp.</b></div> <div>Surveyor Notes:<br/><b>N/A</b></div> <div>PROW/ADA:<br/><b>R304.2.2</b></div> <div>Total Cost:\$ 1600.00</div> | | | | Compliance | Description | Data | Compliance | Description | Data |
