Access Compliance Report

Public Rights-of-Way

(Curb Ramps)

Intersection ID: 53326	Main Street: FLINT_HILL_DR	Cross Street: CALAWOOD_WY	Location: SE
ADA ID: 0524D7EEE7EE	Ramp Type: BlendTrans1	Initial Pass/Fail: Fail	Overall Compliance: No
Severity Score: 1.25			
Codes/Mitigation Info/Possible Solution		Field Measurements/Component Compliance

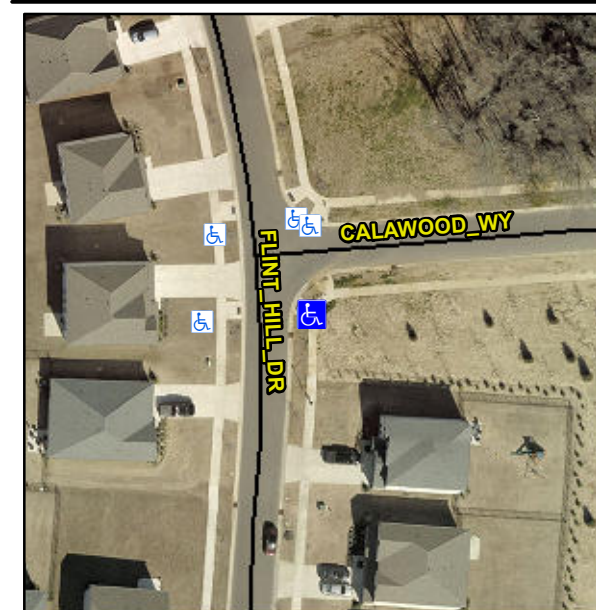
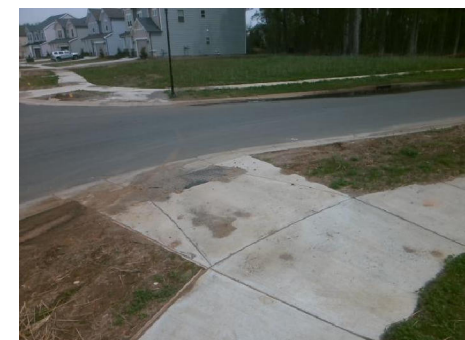
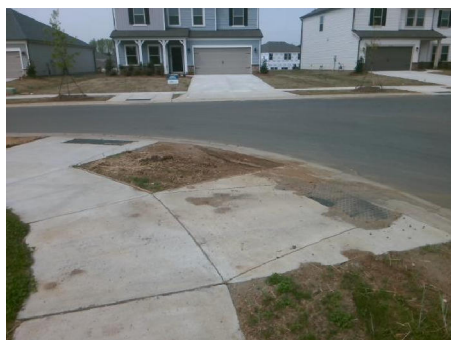
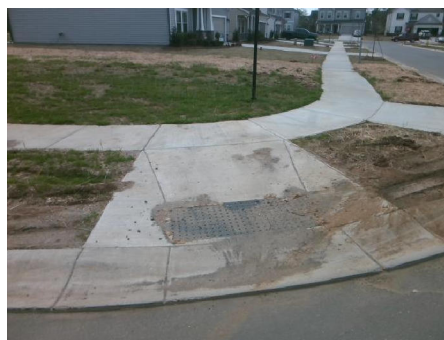
Compliance	Description	Data	Compliance	Description	Data
N/A	Ramp Length (in)	96.0	Yes	BlendTrans Slope (%)	4.3
Yes	Ramp Width (in)	48.0	No	BlendTrans XSlope (%)	2.4
N/A	Flare Type LT	N/A	N/A	Flare Type RT	N/A
N/A	Flare Slope LT (%)	N/A	N/A	Flare Slope RT (%)	N/A
N/A	Flare Traversable LT?	N/A	N/A	Flare Traversable RT?	N/A
N/A	Landing Length (in)	N/A	N/A	DWS Provided?	N/A
N/A	Landing Width (in)	N/A	N/A	DWS Contrast?	N/A
N/A	Landing Slope (%)	N/A	N/A	DWS Length (in)	N/A
N/A	Landing X Slope (%)	N/A	N/A	DWS Full Width?	N/A
N/A	Landing Curb? (Y/N)	N/A	N/A	DWS Offset (in)	N/A
N/A	Shared Landing?	N/A			
N/A	Gutter Ponding?	N/A	N/A	Gutter Slope (%)	N/A
N/A	Gutter Lip Ht (in)	1.0	N/A	Gutter X Slope (%)	N/A
N/A	Painted X Walk1?	No	N/A	Painted X Walk2?	N/A
	X Walk 1 Direction	To N		X Walk 2 Direction	N/A
	X Walk 1 Width (in)	N/A		X Walk 2 Width (in)	N/A
	X Walk 1 Slope (%)	0.1		X Walk 2 Slope (%)	N/A
	X Walk 1 X Slope (%)	2.2		X Walk 2 X Slope (%)	N/A

N/A	Ramp inside XWalk1?	N/A	N/A	Ramp inside XWalk2?	N/A
	Road Slope (%)	2.2		Clear Space?	N/A
	Road X Slope (%)	0.1	N/A	Clear Space to XWalk (in)	N/A
N/A	Any Obstructions?	N/A	N/A	Storm Grate/Utility Hazard?	N/A
	Obstruction Type			Storm Grate/Utility Type	
		N/A			N/A
			Yes	Surface Condition? (G/P)	Good
			N/A	Curb Slope (%)	2.4

Remove & Replace Curb Ramp With Two New Directional Ramps or Equivalent.

R304.5.3
