# Access Compliance Report

## Public Rights-of-Way

### (Curb Ramps)

| Intersection ID: 8447 | Main Street: CENTRE_ST | Cross Street: KENTUCKY_AV | Location: SW |

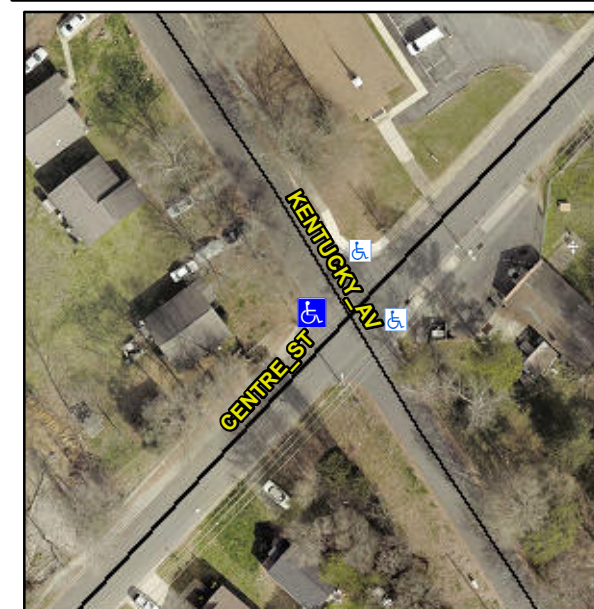
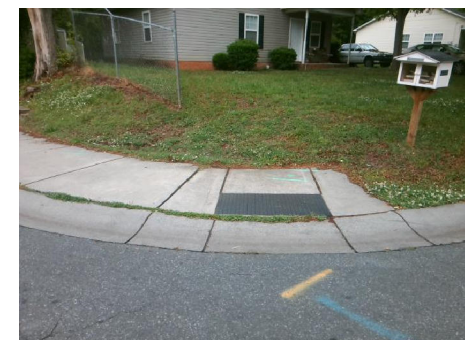
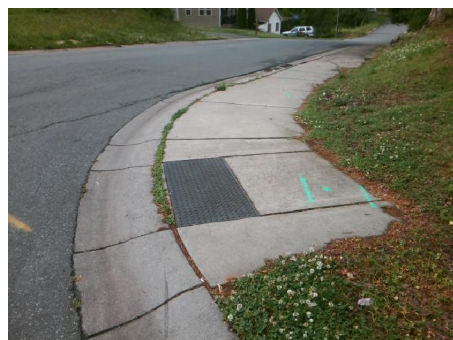
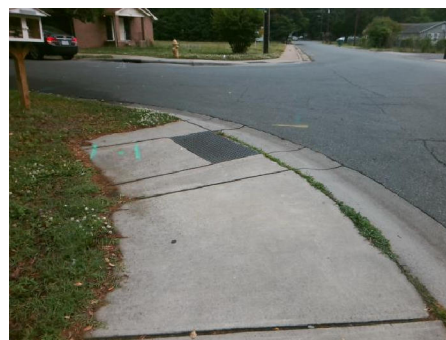
**NO RT SW**

**Not Found, R304.5.3, R304.2.1, R304.5.4**

| Compliance | Description | Data | Compliance | Description | Data |
|---|---|---|---|---|---|
| Yes | Ramp Width (in) | 48.0 | No | BlendTrans XSlope (%) | 3.9 |
| No | Landing Length (in) | 45.1 | Yes | DWS Provided? | Yes |
| Yes | Gutter Ponding? | No | No | Gutter Slope (%) | 9.7 |
| | | | No | Curb Slope (%) | 14.9 |

**Remove & Replace Curb Ramp With Two New Directional Ramps or Equivalent. Remove & Replace Gutter.**
