Access Compliance Report

Public Rights-of-Way

(Curb Ramps)

Intersection ID: 27388	Main Street: CONLAN_CR	Cross Street: BRIXHAM_HILL_AV	Location: NW
ADA ID: 053A720393AA	Ramp Type: Para	Initial Pass/Fail: Fail	Overall Compliance: No
			Severity Score: 13.75

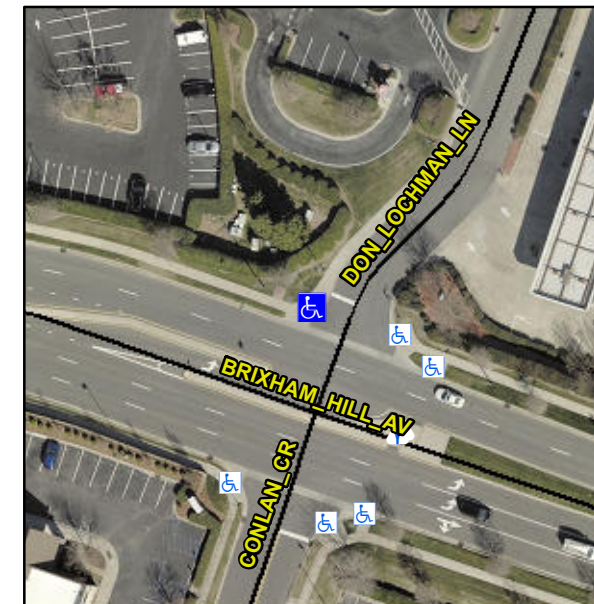
RT RP < 5%

R304.3.2, R304.5.3

Compliance	Description	Data	Compliance	Description	Data
N/A	Ramp Length LT (in)	30.0	N/A	Ramp Length RT (in)	40.0
Yes	Ramp Width LT (in)	60.0	Yes	Ramp Width RT (in)	60.0
No	Ramp Slope LT (%)	8.6	Yes	Ramp Slope RT (%)	1.3
No	Ramp XSlope LT (%)	2.3	No	Ramp XSlope RT (%)	2.5
N/A	Landing Length (in)	N/A	N/A	DWS Provided?	N/A
N/A	Landing Width (in)	N/A	N/A	DWS Contrast?	N/A
N/A	Landing Slope (%)	N/A	N/A	DWS Length (in)	N/A
N/A	Landing X Slope (%)	N/A	N/A	DWS Full Width?	N/A
N/A	Landing Curb? (Y/N)	N/A	N/A	DWS Offset (in)	N/A
N/A	Shared Landing?	N/A			
N/A	Gutter Ponding?	N/A	N/A	Gutter Slope (%)	N/A
N/A	Gutter Lip Ht (in)	N/A	N/A	Gutter X Slope (%)	N/A
N/A	Painted X Walk1?	No	N/A	Painted X Walk2?	N/A
	X Walk 1 Direction	To SE		X Walk 2 Direction	N/A
N/A	X Walk 1 Width (in)	N/A	N/A	X Walk 2 Width (in)	N/A
	X Walk 1 Slope (%)	2.3		X Walk 2 Slope (%)	N/A
	X Walk 1 X Slope (%)	6.4		X Walk 2 X Slope (%)	N/A
N/A	Ramp inside XWalk1?	N/A	N/A	Ramp inside XWalk2?	N/A

Road Slope (%)	N/A	N/A	Clear Space?	N/A
	Road X Slope (%)	N/A	N/A	Clear Space to XWalk (in)	N/A
N/A	Any Obstructions?	N/A	N/A	Storm Grate/Utility Hazard?	N/A
	Obstruction Type			Storm Grate/Utility Type	
		N/A			N/A
			Yes	Surface Condition? (G/P)	Good
			N/A	Curb Slope (%)	3.0

Remove & Replace Entire Ramp.
