## **Access Compliance Report Public Rights-of-Way** (Curb Ramps)

Intersection ID: 8673 Main Street: ROWAN\_ST Cross Street: TILLMAN\_RD Location: SW ADA ID: 054862B738F5 Ramp Type: Para Initial Pass/Fail: Fail **Overall Compliance: No** Severity Score: 13.75

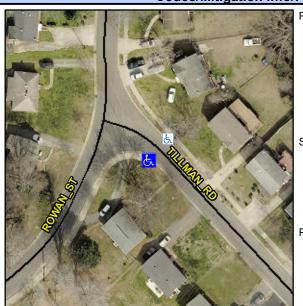
Possible Solutions: Remove & Replace Entire Ramp. Surveyor Notes: NO LT SW, LT RP < 5% PROW/ADA: R304.5.3, R304.3.2

Field Measurements/Component Compliance					
Compliance Description		Data	Compliance Description		Data
N/A	Ramp Length LT (in)	62.0	N/A	Ramp Length RT (in)	61.0
Yes	Ramp Width LT (in)	72.0	Yes	Ramp Width RT (in)	72.0
Yes	Ramp Slope LT (%)	2.9	No	Ramp Slope RT (%)	11.2
No	Ramp XSlope LT (%)	2.6	No	Ramp XSlope RT (%)	3.0
N/A	Landing Length (in)	N/A	N/A	DWS Provided?	N/A
N/A	Landing Width (in)	N/A	N/A	DWS Contrast?	N/A
N/A	Landing Slope (%)	N/A	N/A	DWS Length (in)	N/A
N/A	Landing X Slope (%)	N/A	N/A	DWS Full Width?	N/A
N/A	Landing Curb? (Y/N)	N/A	N/A	DWS Offset (in)	N/A
N/A	Shared Landing?	N/A			
N/A	Gutter Ponding?	N/A	N/A	Gutter Slope (%)	N/A
N/A	Gutter Lip Ht (in)	N/A	N/A	Gutter X Slope (%)	N/A
N/A	Painted X Walk1?	No	N/A	Painted X Walk2?	N/A
	X Walk 1 Direction	To NE		X Walk 2 Direction	N/A
N/A	X Walk 1 Width (in)	N/A	N/A	X Walk 2 Width (in)	N/A
	X Walk 1 Slope (%)	1.0		X Walk 2 Slope (%)	N/A
	X Walk 1 X Slope (%)	2.6		X Walk 2 X Slope (%)	N/A
