Access Compliance Report

Public Rights-of-Way

(Curb Ramps)

Intersection ID: 9515	Main Street: GRIMES_ST	Cross Street: W_28TH_ST	Location: N
ADA ID: 055038E6FF97	Ramp Type: Perp	Initial Pass/Fail: Fail	Overall Compliance: No
Severity Score: 8.75			
Codes/Mitigation Info/Possible Solution		Field Measurements/Component Compliance

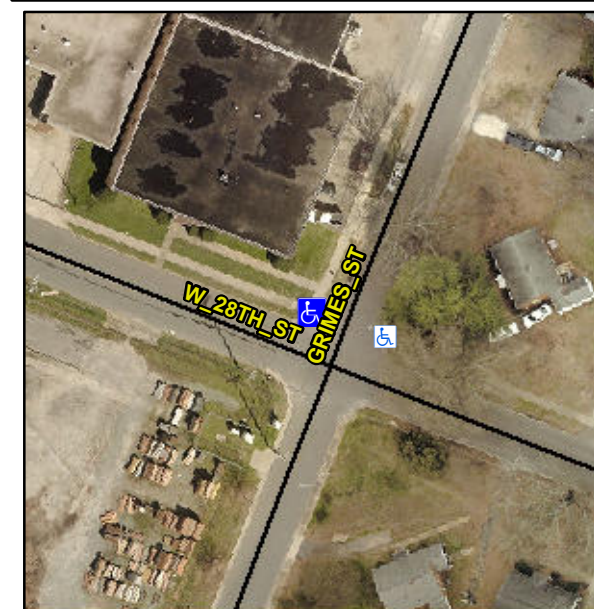
Not Found, R304.5.1

Compliance	Description	Data	Compliance	Description	Data
N/A	Ramp Length (in)	59.5	Yes	Ramp Slope (%)	7.4
No	Ramp Width (in)	47.5	Yes	Ramp XSlope (%)	1.4
N/A	Flare Type LT	N/A	N/A	Flare Type RT	N/A
N/A	Flare Slope LT (%)	N/A	N/A	Flare Slope RT (%)	N/A
N/A	Flare Traversable LT?	N/A	N/A	Flare Traversable RT?	N/A
N/A	Landing Length (in)	N/A	N/A	DWS Provided?	N/A
N/A	Landing Width (in)	N/A	N/A	DWS Contrast?	N/A
N/A	Landing Slope (%)	N/A	N/A	DWS Length (in)	N/A
N/A	Landing X Slope (%)	N/A	N/A	DWS Full Width?	N/A
N/A	Landing Curb? (Y/N)	N/A	N/A	DWS Offset (in)	N/A
N/A	Shared Landing?	N/A			
N/A	Gutter Ponding?	N/A	N/A	Gutter Slope (%)	N/A
N/A	Gutter Lip Ht (in)	0.5	N/A	Gutter X Slope (%)	N/A
N/A	Painted X Walk1?	No	N/A	Painted X Walk2?	N/A
	X Walk 1 Direction	To SE		X Walk 2 Direction	N/A
N/A	X Walk 1 Width (in)	N/A	N/A	X Walk 2 Width (in)	N/A
	X Walk 1 Slope (%)	1.5		X Walk 2 Slope (%)	N/A
	X Walk 1 X Slope (%)	0.5		X Walk 2 X Slope (%)	N/A

Possible Solutions:

Remove & Replace Entire Ramp.
