# Access Compliance Report

## Public Rights-of-Way

### (Curb Ramps)

| Intersection ID: 50583 | Main Street: GRAND_FIR_RD | Cross Street: LONGSTRAW_RD | Location: SW |

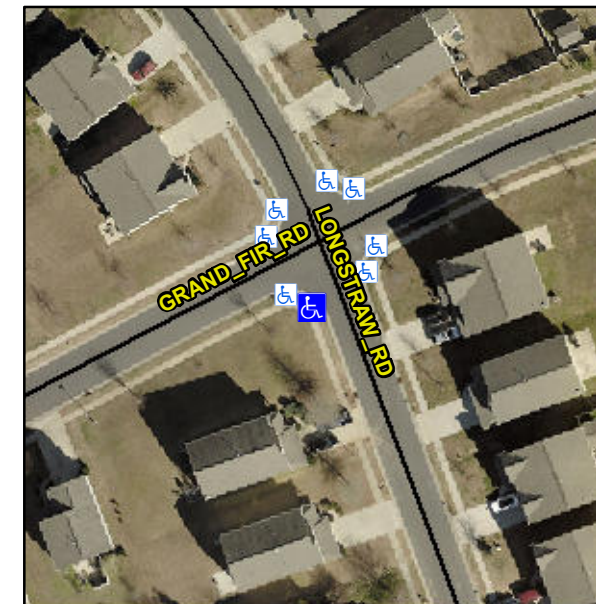
| ADA ID: 0554CAF57D44 | Ramp Type: Perp | Initial Pass/Fail: Fail | Overall Compliance: No |
| Severity Score: 12.5 | | | |

**Not Found, R304.5.3**

| Compliance | Description | Data | Compliance | Description | Data |
|---|---|---|---|---|---|
| Yes | Ramp Width (in) | 48.0 | No | Ramp XSlope (%) | 6.7 |

Possible Solutions:

**Remove & Replace Entire Ramp.**
