Access Compliance Report

Public Rights-of-Way

(Curb Ramps)

Intersection ID: 31250	Main Street: DAVID_COX_RD	Cross Street: HARRIS_COVE_DR	Location: N
ADA ID: 0559102CD722	Ramp Type: Perp	Initial Pass/Fail: Fail	Overall Compliance: No
Severity Score: 8.75			
Codes/Mitigation Info/Possible Solution		Field Measurements/Component Compliance

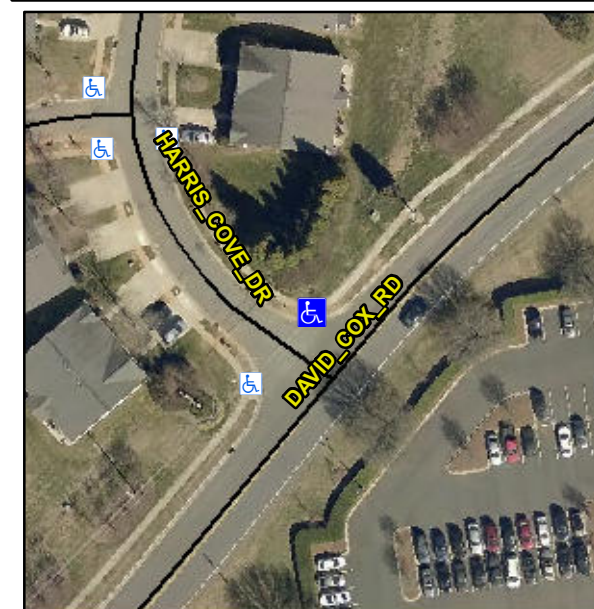
Compliance	Description	Data	Compliance	Description	Data
N/A	Ramp Length (in)	48.0	Yes	Ramp Slope (%)	7.9
No	Ramp Width (in)	43.0	Yes	Ramp XSlope (%)	0.3
N/A	Flare Type LT	N/A	N/A	Flare Type RT	N/A
N/A	Flare Slope LT (%)	N/A	N/A	Flare Slope RT (%)	N/A
N/A	Flare Traversable LT?	N/A	N/A	Flare Traversable RT?	N/A
N/A	Landing Length (in)	N/A	N/A	DWS Provided?	N/A
N/A	Landing Width (in)	N/A	N/A	DWS Contrast?	N/A
N/A	Landing Slope (%)	N/A	N/A	DWS Length (in)	N/A
N/A	Landing X Slope (%)	N/A	N/A	DWS Full Width?	N/A
N/A	Landing Curb? (Y/N)	N/A	N/A	DWS Offset (in)	N/A
N/A	Shared Landing?	N/A			
N/A	Gutter Ponding?	N/A	N/A	Gutter Slope (%)	N/A
N/A	Gutter Lip Ht (in)	N/A	N/A	Gutter X Slope (%)	N/A
N/A	Painted X Walk1?	No	N/A	Painted X Walk2?	N/A
	X Walk 1 Direction	To SW		X Walk 2 Direction	N/A
N/A	X Walk 1 Width (in)	N/A	N/A	X Walk 2 Width (in)	N/A
	X Walk 1 Slope (%)	0.1		X Walk 2 Slope (%)	N/A
	X Walk 1 X Slope (%)	1.2		X Walk 2 X Slope (%)	N/A

N/A	Ramp inside XWalk1?	N/A	N/A	Ramp inside XWalk2?	N/A
	Road Slope (%)	N/A	N/A	Clear Space?	N/A
	Road X Slope (%)	N/A	N/A	Clear Space to XWalk (in)	N/A
N/A	Any Obstructions?	N/A	N/A	Storm Grate/Utility Hazard?	N/A
	Obstruction Type			Storm Grate/Utility Type	
		N/A			N/A
		Yes		Surface Condition? (G/P)	Good

Possible Solutions:

Remove & Replace Entire Ramp.

R304.5.1
