Access Compliance Report

Public Rights-of-Way

(Curb Ramps)

| Intersection ID: 10040201 | Main Street: TYVOLA_RD | Cross Street: N/A | Location: SE |

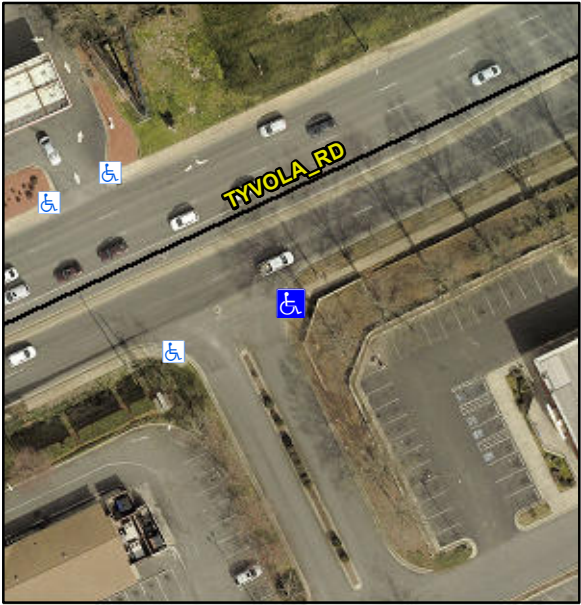
| ADA ID: 055CCA79D7C2 | Ramp Type: Directional1 | Initial Pass/Fail: Fail | Overall Compliance: No |

| | | No | Ramp XSlope (%) | 5.0 | | | |
| | PROW/ADA: R304.5.3 | N/A | Landing Slope (%) | 0.0 | N/A | DWS Length (in) | N/A |

| | Remove & Replace Entire Ramp. | | | | | | |
