Access Compliance Report

Public Rights-of-Way

(Curb Ramps)

Intersection ID: 48946	Main Street: DAVID_JENNINGS_AV	Cross Street: MITCHELL_GRANT_WY	Location: W
ADA ID: 056525F7EE44	Ramp Type: Perp	Initial Pass/Fail: Fail	Overall Compliance: No
Severity Score: 21.25			
Codes/Mitigation Info/Possible Solution		Field Measurements/Component Compliance

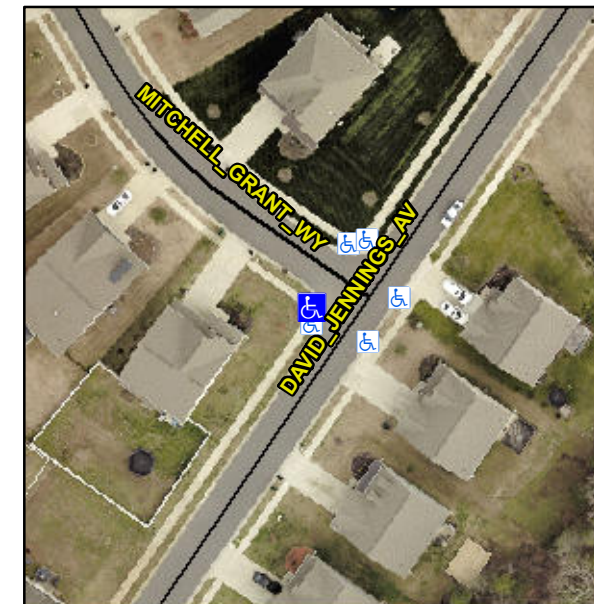
Not Found, R304.5.1, R304.2.2

Compliance	Description	Data	Compliance	Description	Data
N/A	Ramp Length (in)	48.0	No	Ramp Slope (%)	8.9
No	Ramp Width (in)	47.5	Yes	Ramp XSlope (%)	0.7
N/A	Flare Type LT	N/A	N/A	Flare Type RT	N/A
N/A	Flare Slope LT (%)	N/A	N/A	Flare Slope RT (%)	N/A
N/A	Flare Traversable LT?	N/A	N/A	Flare Traversable RT?	N/A
N/A	Landing Length (in)	N/A	N/A	DWS Provided?	N/A
N/A	Landing Width (in)	N/A	N/A	DWS Contrast?	N/A
N/A	Landing Slope (%)	N/A	N/A	DWS Length (in)	N/A
N/A	Landing X Slope (%)	N/A	N/A	DWS Full Width?	N/A
N/A	Landing Curb? (Y/N)	N/A	N/A	DWS Offset (in)	N/A
N/A	Shared Landing?	N/A			
N/A	Gutter Ponding?	N/A	N/A	Gutter Slope (%)	N/A
N/A	Gutter Lip Ht (in)	N/A	N/A	Gutter X Slope (%)	N/A
N/A	Painted X Walk1?	No	N/A	Painted X Walk2?	N/A
	X Walk 1 Direction	To NE		X Walk 2 Direction	N/A
N/A	X Walk 1 Width (in)	N/A	N/A	X Walk 2 Width (in)	N/A
	X Walk 1 Slope (%)	0.7		X Walk 2 Slope (%)	N/A
	X Walk 1 X Slope (%)	0.1		X Walk 2 X Slope (%)	N/A

N/A	Ramp inside XWalk1?	N/A	N/A	Ramp inside XWalk2?	N/A
	Road Slope (%)	N/A	N/A	Clear Space?	N/A
	Road X Slope (%)	N/A	N/A	Clear Space to XWalk (in)	N/A
N/A	Any Obstructions?	N/A	N/A	Storm Grate/Utility Hazard?	N/A
	Obstruction Type			Storm Grate/Utility Type	
		N/A			N/A
			Yes	Surface Condition? (G/P)	Good

Possible Solutions:

Remove & Replace Entire Ramp.
