Access Compliance Report

Public Rights-of-Way

(Curb Ramps)

Intersection ID: 49797	Main Street: ATKINS_RIDGE_DR	Cross Street: PARSIFAL_LN	Location: S
ADA ID: 05687AD57BC1	Ramp Type: PerpDiag	Initial Pass/Fail: Fail	Overall Compliance: No
Severity Score: 21.25			
Codes/Mitigation Info/Possible Solution		Field Measurements/Component Compliance

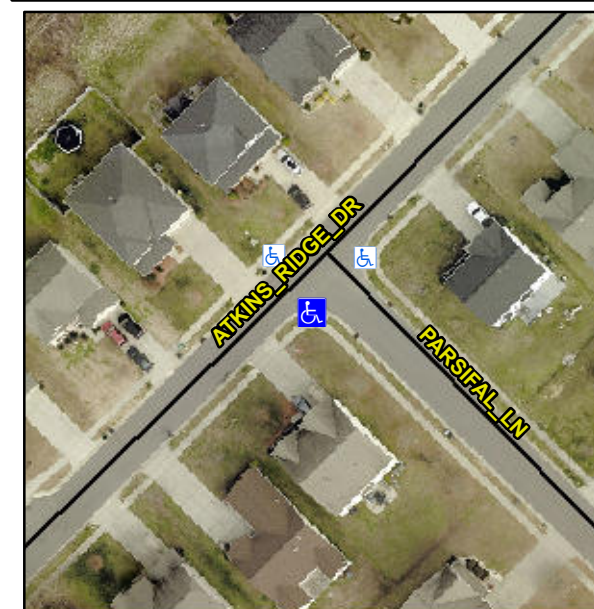
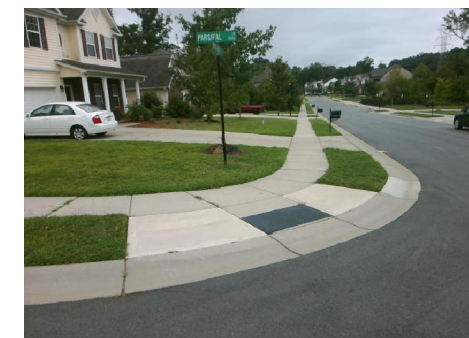
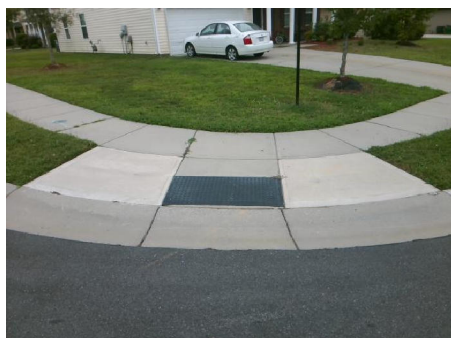
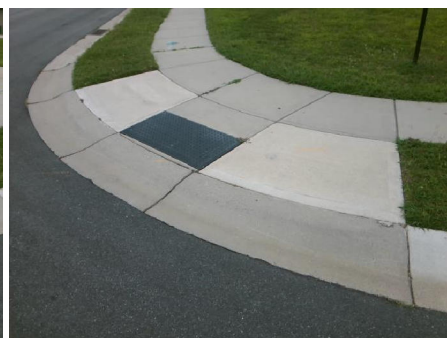
Not Found, R304.5.1, R304.5.3

Compliance	Description	Data	Compliance	Description	Data
N/A	Ramp Length (in)	47.0	Yes	Ramp Slope (%)	6.9
No	Ramp Width (in)	47.0	No	Ramp XSlope (%)	5.8
N/A	Flare Type LT	N/A	N/A	Flare Type RT	N/A
N/A	Flare Slope LT (%)	N/A	N/A	Flare Slope RT (%)	N/A
N/A	Flare Traversable LT?	N/A	N/A	Flare Traversable RT?	N/A
N/A	Landing Length (in)	N/A	N/A	DWS Provided?	N/A
N/A	Landing Width (in)	N/A	N/A	DWS Contrast?	N/A
N/A	Landing Slope (%)	N/A	N/A	DWS Length (in)	N/A
N/A	Landing X Slope (%)	N/A	N/A	DWS Full Width?	N/A
N/A	Landing Curb? (Y/N)	N/A	N/A	DWS Offset (in)	N/A
N/A	Shared Landing?	N/A			
N/A	Gutter Ponding?	N/A	N/A	Gutter Slope (%)	N/A
N/A	Gutter Lip Ht (in)	N/A	N/A	Gutter X Slope (%)	N/A
N/A	Painted X Walk1?	No	N/A	Painted X Walk2?	No
	X Walk 1 Direction	To NE		X Walk 2 Direction	To NW
N/A	X Walk 1 Width (in)	N/A	N/A	X Walk 2 Width (in)	N/A
	X Walk 1 Slope (%)	4.3		X Walk 2 Slope (%)	3.6
	X Walk 1 X Slope (%)	0.5		X Walk 2 X Slope (%)	5.9

N/A	Ramp inside XWalk1?	N/A	N/A	Ramp inside XWalk2?	N/A
	Road Slope (%)	2.9	N/A	Clear Space?	N/A
	Road X Slope (%)	6.4	N/A	Clear Space to XWalk (in)	N/A
N/A	Any Obstructions?	N/A	N/A	Storm Grate/Utility Hazard?	N/A
	Obstruction Type			Storm Grate/Utility Type	
		N/A			N/A
		Yes		Surface Condition? (G/P)	Good

Remove & Replace Curb Ramp With Two New Directional Ramps or Equivalent.
