Access Compliance Report

Public Rights-of-Way

(Curb Ramps)

Intersection ID: 48951	Main Street: GATESMILLS_AV	Cross Street: JOSHUA_CAIN_RD	Location: NW
ADA ID: 05766ED8A846	Ramp Type: Perp	Initial Pass/Fail: Fail	Overall Compliance: No
			Severity Score: 21.25

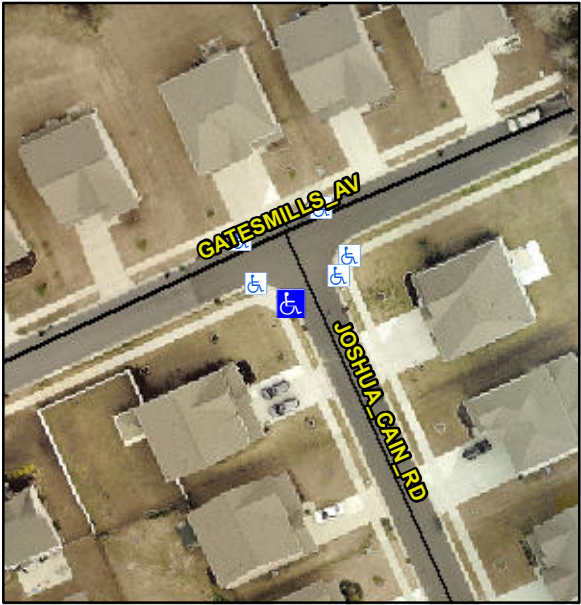
Possible Solutions:		Compliance	Description	Data
	Remove & Replace Entire Ramp.		No	Ramp Length (in)	47.5
			No	Ramp Width (in)	47.5
			N/A	Flare Type LT	N/A
			N/A	Flare Slope LT (%)	N/A
			N/A	Flare Traversable LT?	N/A
			N/A	Landing Length (in)	N/A
			N/A	Landing Width (in)	N/A
			N/A	Landing Slope (%)	N/A
			N/A	Landing X Slope (%)	N/A
<p>Surveyor Notes:</p> <p>N/A</p> <p>PROW/ADA:</p> <p>Not Found, R304.5.1, R304.2.2</p>			N/A	Flare Type RT	N/A
			N/A	Flare Slope RT (%)	N/A
			N/A	Flare Traversable RT?	N/A
			N/A	DWS Provided?	N/A
			N/A	DWS Contrast?	N/A
			N/A	DWS Length (in)	N/A
			N/A	DWS Full Width?	N/A
			N/A	DWS Offset (in)	N/A
			N/A	Gutter Ponding?	N/A
			N/A	Gutter Lip Ht (in)	1.0
			No	Painted X Walk1?	N/A
				X Walk 1 Direction	To E
			N/A	X Walk 1 Width (in)	N/A
				X Walk 1 Slope (%)	2.1
				X Walk 1 X Slope (%)	1.1

N/A	Ramp inside XWalk1?	N/A
			N/A	Road Slope (%)	N/A
			N/A	Road X Slope (%)	N/A
			N/A	Any Obstructions?	N/A
				Obstruction Type	
Total Cost: \$ 1850.00			N/A	Storm Grate/Utility Hazard?	N/A
				Storm Grate/Utility Type	
			N/A		N/A
			Yes	Surface Condition? (G/P)	Good
