## Access Compliance Report Public Rights-of-Way (Curb Ramps)

Intersection ID: 30565Main Street:CIRCLEGREEN\_DRCross Street:GREENCREEK\_DRLocation:NEADA ID: 05777573774FRamp Type:BlendTrans2Initial Pass/Fail:FailOverall Compliance:NoSeverity Score:25

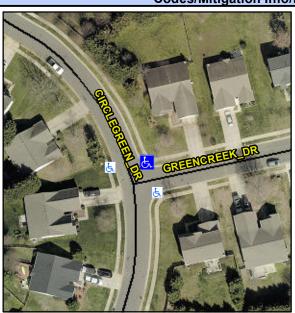
Comp	liance Description	Data Compliance Description			Data
	N/A	Ramp Length (in)	94.0	Yes	BlendTrans Slope (%)	4.8
	Yes	Ramp Width (in)	48.0	No	BlendTrans XSlope (%)	7.3
	N/A	Flare Type LT	N/A	N/A	Flare Type RT	N/A
	N/A	Flare Slope LT (%)	N/A	N/A	Flare Slope RT (%)	N/A
	N/A	Flare Traversable LT?	N/A	N/A	Flare Traversable RT?	N/A
	N/A	Landing Length (in)	N/A	N/A	DWS Provided?	N/A
	N/A	Landing Width (in)	N/A	N/A	DWS Contrast?	N/A
	N/A	Landing Slope (%)	N/A	N/A	DWS Length (in)	N/A
	N/A	Landing X Slope (%)	N/A	N/A	DWS Full Width?	N/A
	N/A	Landing Curb? (Y/N)	N/A	N/A	DWS Offset (in)	N/A
	N/A	Shared Landing?	N/A			
	N/A	Gutter Ponding?	N/A	N/A	Gutter Slope (%)	N/A
	N/A	Gutter Lip Ht (in)	N/A	N/A	Gutter X Slope (%)	N/A
	N/A	Painted X Walk1?	No	N/A	Painted X Walk2?	No
		X Walk 1 Direction	To W		X Walk 2 Direction	To S
		X Walk 1 Width (in)	N/A		X Walk 2 Width (in)	N/A
		X Walk 1 Slope (%)	5.5		X Walk 2 Slope (%)	3.4

X Walk 1 X Slope (%)	1.5		X Walk 2 X Slope (%)	3.1
	N/A	Ramp inside XWalk1?	N/A	N/A	Ramp inside XWalk2?	N/A
		Road Slope (%)	2.8		Clear Space?	N/A
		Road X Slope (%)	5.3	N/A	Clear Space to XWalk (in)	N/A
	N/A	Any Obstructions?	N/A	N/A	Storm Grate/Utility Hazard?	N/A
		Obstruction Type		l	Storm Grate/Utility Type	
			N/A	l		N/A
				Yes	Surface Condition? (G/P)	Good
in the same	2			N/A	Curb Slope (%)	3.5

Remove & Replace Curb Ramp With Two New Directional Ramps or Equivalent.

R304.5.3
