Access Compliance Report

Public Rights-of-Way

(Curb Ramps)

Intersection ID: 48147	Main Street: MCCAMEY_DR	Cross Street: FRANKLIN_MEADOWS_DR	Location: NW
ADA ID: 058041B5A4A1	Ramp Type: Perp	Initial Pass/Fail: Fail	Overall Compliance: No
			Severity Score: 13.75

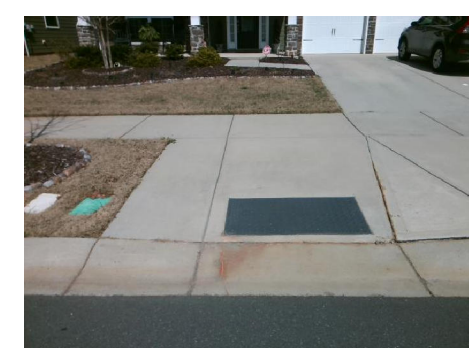
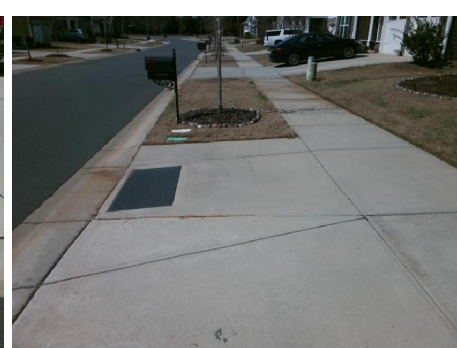
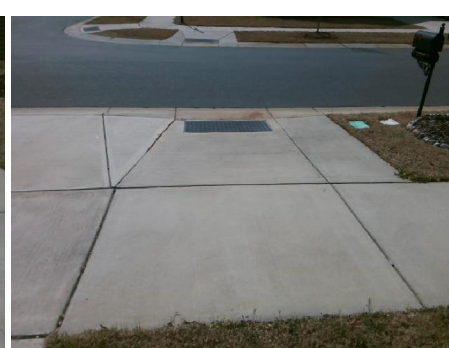
Possible Solutions:		Compliance	Description	Data
	Remove & Replace Entire Ramp.		N/A	Ramp Length (in)	96.0
			Yes	Ramp Width (in)	60.0
			N/A	Flare Type LT	N/A
			N/A	Flare Slope LT (%)	N/A
			N/A	Flare Traversable LT?	N/A
			N/A	Landing Length (in)	N/A
			N/A	Landing Width (in)	N/A
			N/A	Landing Slope (%)	N/A
			N/A	Landing X Slope (%)	N/A
<p>Surveyor Notes:</p> <p>N/A</p> <p>PROW/ADA:</p> <p>R304.2.2, R304.5.3</p>			N/A	Flare Type RT	N/A
			N/A	Flare Slope RT (%)	N/A
			N/A	Flare Traversable RT?	N/A
			N/A	DWS Provided?	N/A
			N/A	DWS Contrast?	N/A
			N/A	DWS Length (in)	N/A
			N/A	DWS Full Width?	N/A
			N/A	DWS Offset (in)	N/A
			N/A	Shared Landing?	N/A
			N/A	Gutter Ponding?	N/A
			N/A	Gutter Lip Ht (in)	N/A
			N/A	Painted X Walk1?	No
				X Walk 1 Direction	To S
			N/A	X Walk 1 Width (in)	N/A
				X Walk 1 Slope (%)	4.3
				X Walk 1 X Slope (%)	1.2

N/A	Ramp inside XWalk1?	N/A
				Road Slope (%)	N/A
				Road X Slope (%)	N/A
			N/A	Any Obstructions?	N/A
				Obstruction Type	
Total Cost:		\$ 1850.00			
			N/A		N/A
			Yes	Surface Condition? (G/P)	Good
