# Access Compliance Report

## Public Rights-of-Way

### (Curb Ramps)

Intersection ID: 4445	Main Street: DASHIEL_DR	Cross Street: SILVER_GLEN_LN	Location: E
ADA ID: 058DE154BE3A	Ramp Type: PerpDiag	Initial Pass/Fail: Fail	Overall Compliance: No
		Severity Score: 10

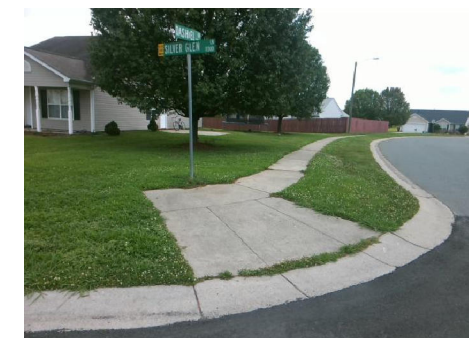
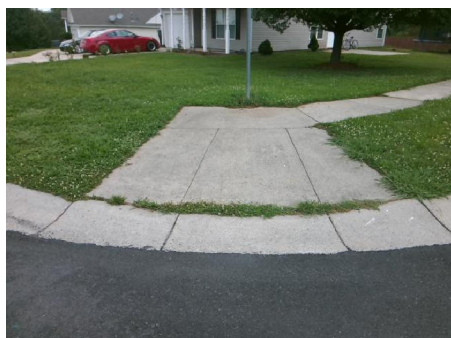
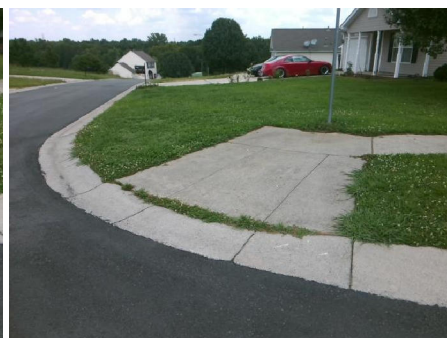
**Not Found, R304.5.1, R304.5.3**

Compliance	Description	Data	Compliance	Description	Data
N/A	Ramp Length (in)	87.0	Yes	Ramp Slope (%)	6.5
No	Ramp Width (in)	38.0	No	Ramp XSlope (%)	2.6
N/A	Flare Type LT	N/A	N/A	Flare Type RT	N/A
N/A	Flare Slope LT (%)	N/A	N/A	Flare Slope RT (%)	N/A
N/A	Flare Traversable LT?	N/A	N/A	Flare Traversable RT?	N/A
N/A	Landing Length (in)	N/A	N/A	DWS Provided?	N/A
N/A	Landing Width (in)	N/A	N/A	DWS Contrast?	N/A
N/A	Landing Slope (%)	N/A	N/A	DWS Length (in)	N/A
N/A	Landing X Slope (%)	N/A	N/A	DWS Full Width?	N/A
N/A	Landing Curb? (Y/N)	N/A	N/A	DWS Offset (in)	N/A
N/A	Shared Landing?	N/A			
N/A	Gutter Ponding?	N/A	N/A	Gutter Slope (%)	N/A
N/A	Gutter Lip Ht (in)	N/A	N/A	Gutter X Slope (%)	N/A
N/A	Painted X Walk1?	No	N/A	Painted X Walk2?	No
	X Walk 1 Direction	To NW		X Walk 2 Direction	To SW
N/A	X Walk 1 Width (in)	N/A	N/A	X Walk 2 Width (in)	N/A
	X Walk 1 Slope (%)	1.9		X Walk 2 Slope (%)	0.8
	X Walk 1 X Slope (%)	0.9		X Walk 2 X Slope (%)	2.3

N/A	Ramp inside XWalk1?	N/A	N/A	Ramp inside XWalk2?	N/A
	Road Slope (%)	1.8	N/A	Clear Space?	N/A
	Road X Slope (%)	2.9	N/A	Clear Space to XWalk (in)	N/A
N/A	Any Obstructions?	N/A	N/A	Storm Grate/Utility Hazard?	N/A
	Obstruction Type			Storm Grate/Utility Type	
		N/A			N/A
			Yes	Surface Condition? (G/P)	Good

**Remove & Replace Curb Ramp With Two New Directional Ramps or Equivalent.**

Total Cost: \$ 3200.00
