# Access Compliance Report

## Public Rights-of-Way

### (Curb Ramps)

Intersection ID: N/A	Main Street: S_BREVARD_ST	Cross Street: E_4TH_ST	Location: SE
ADA ID: 058DE96C9959	Ramp Type: PerpDiag	Initial Pass/Fail: Fail	Overall Compliance: No
Severity Score: 12.5			
Codes/Mitigation Info/Possible Solution		Field Measurements/Component Compliance

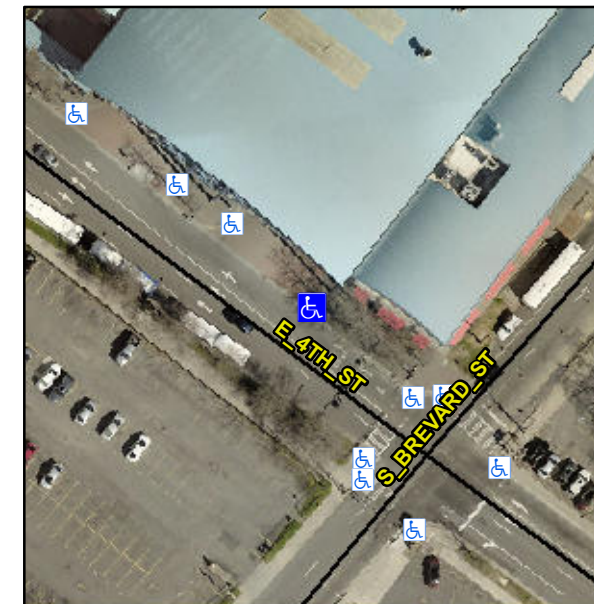
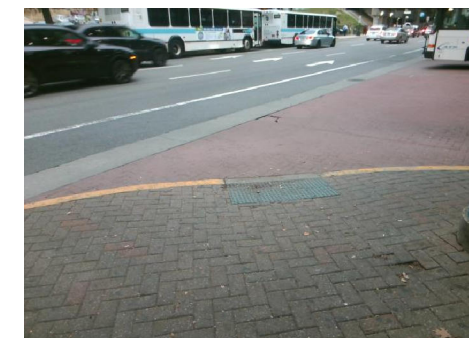
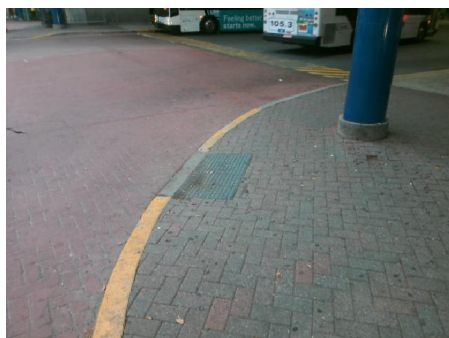
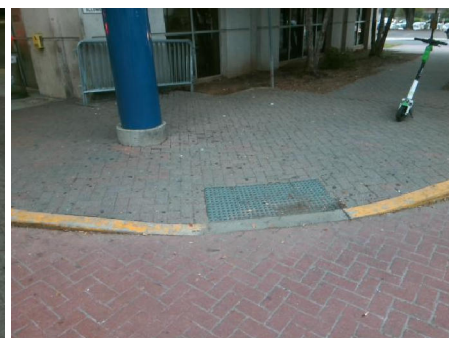
Compliance	Description	Data	Compliance	Description	Data
N/A	Ramp Length (in)	96.0	No	Ramp Slope (%)	8.7
Yes	Ramp Width (in)	48.0	Yes	Ramp XSlope (%)	0.2
N/A	Flare Type LT	N/A	N/A	Flare Type RT	N/A
N/A	Flare Slope LT (%)	N/A	N/A	Flare Slope RT (%)	N/A
N/A	Flare Traversable LT?	N/A	N/A	Flare Traversable RT?	N/A
N/A	Landing Length (in)	N/A	N/A	DWS Provided?	N/A
N/A	Landing Width (in)	N/A	N/A	DWS Contrast?	N/A
N/A	Landing Slope (%)	N/A	N/A	DWS Length (in)	N/A
N/A	Landing X Slope (%)	N/A	N/A	DWS Full Width?	N/A
N/A	Landing Curb? (Y/N)	N/A	N/A	DWS Offset (in)	N/A
N/A	Shared Landing?	N/A			
N/A	Gutter Ponding?	N/A	N/A	Gutter Slope (%)	N/A
N/A	Gutter Lip Ht (in)	N/A	N/A	Gutter X Slope (%)	N/A
N/A	Painted X Walk1?	No	N/A	Painted X Walk2?	No
	X Walk 1 Direction	To SE		X Walk 2 Direction	To SW
N/A	X Walk 1 Width (in)	N/A	N/A	X Walk 2 Width (in)	N/A
	X Walk 1 Slope (%)	2.9		X Walk 2 Slope (%)	0.7
	X Walk 1 X Slope (%)	1.3		X Walk 2 X Slope (%)	0.7

N/A	Ramp inside XWalk1?	N/A	N/A	Ramp inside XWalk2?	N/A
	Road Slope (%)	1.3	N/A	Clear Space?	N/A
	Road X Slope (%)	1.6	N/A	Clear Space to XWalk (in)	N/A
N/A	Any Obstructions?	N/A	N/A	Storm Grate/Utility Hazard?	N/A
	Obstruction Type			Storm Grate/Utility Type	
		N/A			N/A
		Yes		Surface Condition? (G/P)	Good

Possible Solutions:

**Remove & Replace Curb Ramp With Two New Directional Ramps or Equivalent.**

**R304.2.2**

**\$ 3200.00**
