Access Compliance Report

Public Rights-of-Way

(Curb Ramps)

Intersection ID: 10270	Main Street: FONTANA_AV	Cross Street: SPRING_ST	Location: NE
ADA ID: 058F89733061	Ramp Type: Directional1	Initial Pass/Fail: Fail	Overall Compliance: No
Severity Score: 13.75			
Codes/Mitigation Info/Possible Solution		Field Measurements/Component Compliance

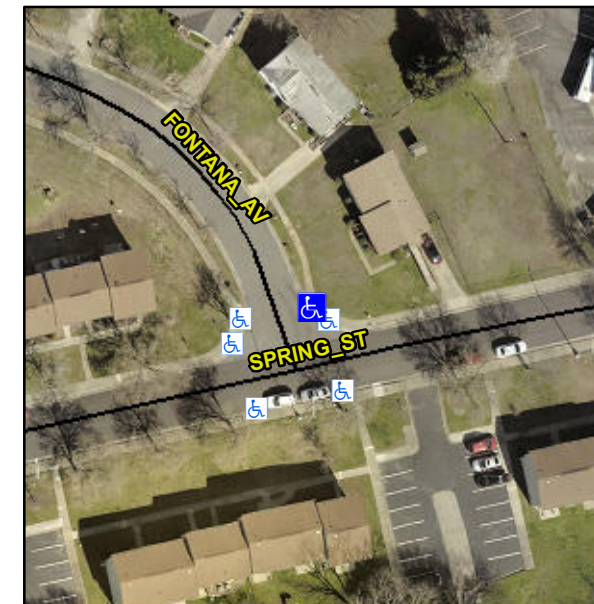
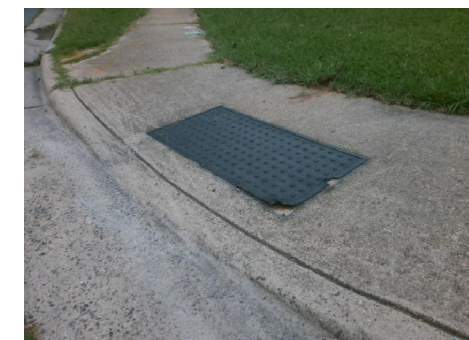
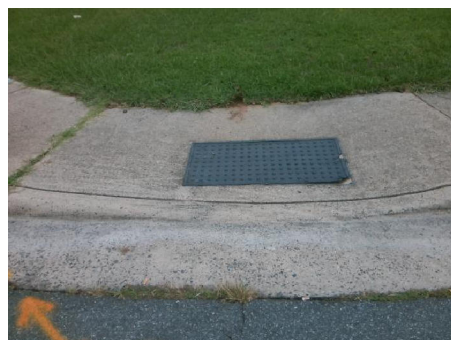
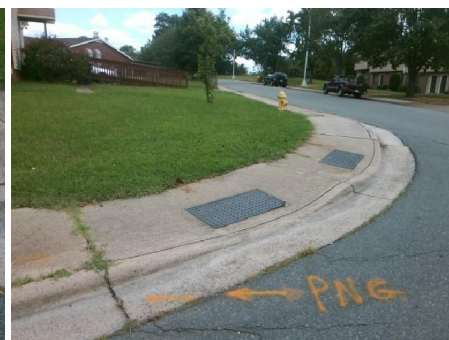
DWS DETACHED/NAILS EXPOSED

R304.2.2, R304.5.3

Compliance	Description	Data	Compliance	Description	Data
N/A	Ramp Length (in)	60.0	N/A	Grade Break?	N/A
Yes	Ramp Width (in)	48.0	N/A	Grade Break Slope (%)	0.0
No	Ramp Slope (%)	8.6	N/A	Grade Break XSlope (%)	0.0
No	Ramp XSlope (%)	4.2			
N/A	Flare Type LT	N/A	N/A	Flare Type RT	N/A
N/A	Flare Slope LT (%)	N/A	N/A	Flare Slope RT (%)	0.0
N/A	Flare Traversable LT?	N/A	N/A	Flare Traversable RT?	N/A
N/A	Landing Length (in)	0.0	N/A	DWS Provided?	N/A
N/A	Landing Width (in)	0.0	N/A	DWS Contrast?	N/A
N/A	Landing Slope (%)	0.0	N/A	DWS Length (in)	N/A
N/A	Landing X Slope (%)	0.0	N/A	DWS Full Width?	N/A
N/A	Landing Curb? (Y/N)	N/A	N/A	DWS Offset LT (in)	N/A
N/A	Shared Landing?	N/A	N/A	DWS Offset RT (in)	N/A
N/A	Gutter Ponding?	0.0	N/A	Gutter Slope (%)	N/A
N/A	Gutter Lip Ht (in)	0.0	N/A	Gutter X Slope (%)	N/A
N/A	Painted X Walk1?	No		Road Slope (%)	1.6
	X Walk 1 Direction	To W		Road X Slope (%)	2.8
	X Walk 1 Width (in)	N/A		Clear Space?	N/A

X Walk 1 Slope (%)	1.6	N/A	Clear Space to XWalk (in)	N/A
	X Walk 1 X Slope (%)	2.8	N/A	Storm Grate/Utility Hazard?	N/A
N/A	Ramp inside XWalk1?	N/A		Storm Grate/Utility Type	
N/A	Any Obstructions?	N/A			N/A
	Obstruction Type		Yes	Surface Condition? (G/P)	Good
			N/A	Curb Slope (%)	21.7

Remove & Replace Entire Ramp.
