Access Compliance Report

Public Rights-of-Way

(Curb Ramps)

Intersection ID: 27446	Main Street: BALLANTYNE_MEADOWS_DR	Cross Street: VALLEY_SPRING_DR	Location: E
ADA ID: 059A0513E54A	Ramp Type: PerpDiag	Initial Pass/Fail: Fail	Overall Compliance: No
Severity Score: 12.5			
Codes/Mitigation Info/Possible Solution		Field Measurements/Component Compliance

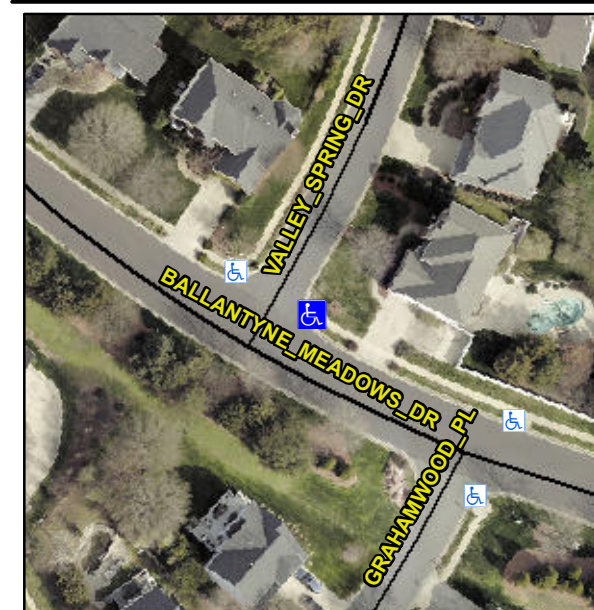
Not Found, R304.2.2

Compliance	Description	Data	Compliance	Description	Data
N/A	Ramp Length (in)	42.0	No	Ramp Slope (%)	11.5
Yes	Ramp Width (in)	48.0	Yes	Ramp XSlope (%)	1.1
N/A	Flare Type LT	N/A	N/A	Flare Type RT	N/A
N/A	Flare Slope LT (%)	N/A	N/A	Flare Slope RT (%)	N/A
N/A	Flare Traversable LT?	N/A	N/A	Flare Traversable RT?	N/A
N/A	Landing Length (in)	N/A	N/A	DWS Provided?	N/A
N/A	Landing Width (in)	N/A	N/A	DWS Contrast?	N/A
N/A	Landing Slope (%)	N/A	N/A	DWS Length (in)	N/A
N/A	Landing X Slope (%)	N/A	N/A	DWS Full Width?	N/A
N/A	Landing Curb? (Y/N)	N/A	N/A	DWS Offset (in)	N/A
N/A	Shared Landing?	N/A			
N/A	Gutter Ponding?	N/A	N/A	Gutter Slope (%)	N/A
N/A	Gutter Lip Ht (in)	N/A	N/A	Gutter X Slope (%)	N/A
N/A	Painted X Walk1?	No	N/A	Painted X Walk2?	No
	X Walk 1 Direction	To NW		X Walk 2 Direction	To SW
N/A	X Walk 1 Width (in)	N/A	N/A	X Walk 2 Width (in)	N/A
	X Walk 1 Slope (%)	0.6		X Walk 2 Slope (%)	2.8
	X Walk 1 X Slope (%)	2.0		X Walk 2 X Slope (%)	1.7

N/A	Ramp inside XWalk1?	N/A	N/A	Ramp inside XWalk2?	N/A
	Road Slope (%)	2.0	N/A	Clear Space?	N/A
	Road X Slope (%)	0.9	N/A	Clear Space to XWalk (in)	N/A
N/A	Any Obstructions?	N/A	N/A	Storm Grate/Utility Hazard?	N/A
	Obstruction Type			Storm Grate/Utility Type	
		N/A			N/A
			Yes	Surface Condition? (G/P)	Good

Possible Solutions:

Remove & Replace Curb Ramp With Two New Directional Ramps or Equivalent.
