Access Compliance Report

Public Rights-of-Way

(Curb Ramps)

Intersection ID: 10024262	Main Street: CRAIG_AV	Cross Street: N/A	Location: NE
ADA ID: 059CE7F15609	Ramp Type: PerpDiag	Initial Pass/Fail: Fail	Overall Compliance: No
Codes/Mitigation Info/Possible Solution		Field Measurements/Component Compliance	
Severity Score: 25

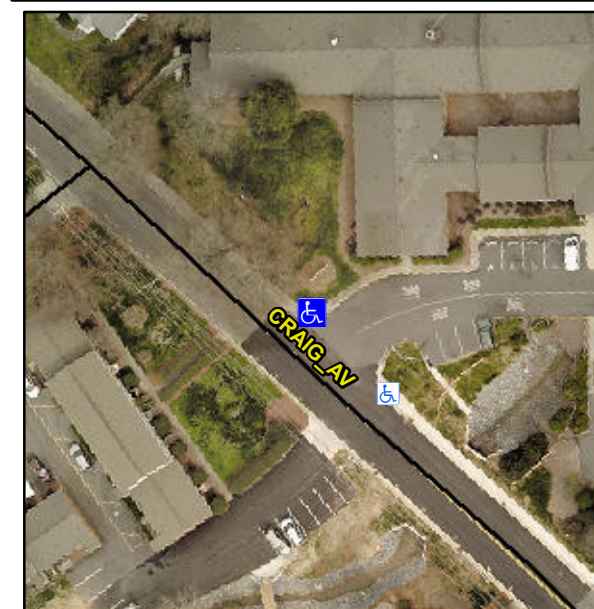
Not Found, R304.2.2

Compliance	Description	Data	Compliance	Description	Data
N/A	Ramp Length (in)	46.0	No	Ramp Slope (%)	16.0
Yes	Ramp Width (in)	48.0	Yes	Ramp XSlope (%)	1.7
N/A	Flare Type LT	N/A	N/A	Flare Type RT	N/A
N/A	Flare Slope LT (%)	N/A	N/A	Flare Slope RT (%)	N/A
N/A	Flare Traversable LT?	N/A	N/A	Flare Traversable RT?	N/A
N/A	Landing Length (in)	N/A	N/A	DWS Provided?	N/A
N/A	Landing Width (in)	N/A	N/A	DWS Contrast?	N/A
N/A	Landing Slope (%)	N/A	N/A	DWS Length (in)	N/A
N/A	Landing X Slope (%)	N/A	N/A	DWS Full Width?	N/A
N/A	Landing Curb? (Y/N)	N/A	N/A	DWS Offset (in)	N/A
N/A	Shared Landing?	N/A			
N/A	Gutter Ponding?	N/A	N/A	Gutter Slope (%)	N/A
N/A	Gutter Lip Ht (in)	N/A	N/A	Gutter X Slope (%)	N/A
N/A	Painted X Walk1?	No	N/A	Painted X Walk2?	No
	X Walk 1 Direction	To SW		X Walk 2 Direction	To SE
N/A	X Walk 1 Width (in)	N/A	N/A	X Walk 2 Width (in)	N/A
	X Walk 1 Slope (%)	4.8		X Walk 2 Slope (%)	2.2
	X Walk 1 X Slope (%)	3.4		X Walk 2 X Slope (%)	5.5

N/A	Ramp inside XWalk1?	N/A	N/A	Ramp inside XWalk2?	N/A
	Road Slope (%)	6.1	N/A	Clear Space?	N/A
	Road X Slope (%)	1.4	N/A	Clear Space to XWalk (in)	N/A
N/A	Any Obstructions?	N/A	N/A	Storm Grate/Utility Hazard?	N/A
	Obstruction Type			Storm Grate/Utility Type	
		N/A			N/A
		Yes		Surface Condition? (G/P)	Good

Remove & Replace Curb Ramp With Two New Directional Ramps or Equivalent.
