# Access Compliance Report

## Public Rights-of-Way

### (Curb Ramps)

Intersection ID: 24081	Main Street: PRESCOTT_POND_LN	Cross Street: SHARPTHORNE_PL	Location: SW
ADA ID: 05A0291D1303	Ramp Type: PerpDiag	Initial Pass/Fail: Fail	Overall Compliance: No
Severity Score: 22.5			
Codes/Mitigation Info/Possible Solution		Field Measurements/Component Compliance

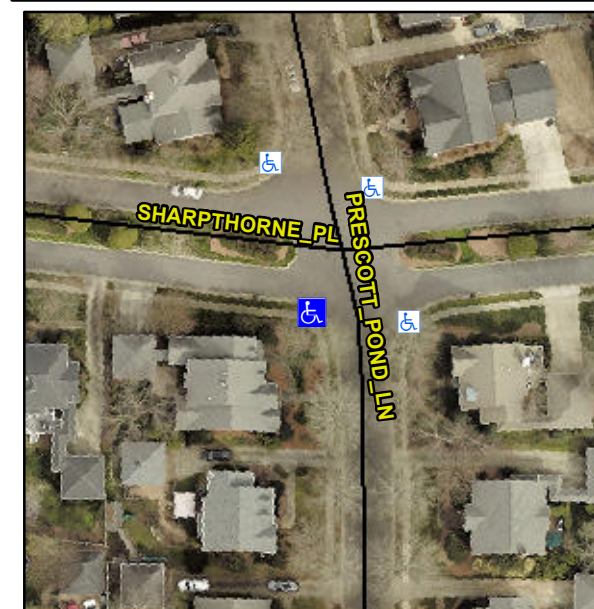
**Not Found, R304.5.1, R304.2.2, R304.5.3**

Compliance	Description	Data	Compliance	Description	Data
N/A	Ramp Length (in)	47.5	No	Ramp Slope (%)	9.0
No	Ramp Width (in)	46.0	No	Ramp XSlope (%)	4.7
N/A	Flare Type LT	N/A	N/A	Flare Type RT	N/A
N/A	Flare Slope LT (%)	N/A	N/A	Flare Slope RT (%)	N/A
N/A	Flare Traversable LT?	N/A	N/A	Flare Traversable RT?	N/A
N/A	Landing Length (in)	N/A	N/A	DWS Provided?	N/A
N/A	Landing Width (in)	N/A	N/A	DWS Contrast?	N/A
N/A	Landing Slope (%)	N/A	N/A	DWS Length (in)	N/A
N/A	Landing X Slope (%)	N/A	N/A	DWS Full Width?	N/A
N/A	Landing Curb? (Y/N)	N/A	N/A	DWS Offset (in)	N/A
N/A	Shared Landing?	N/A			
N/A	Gutter Ponding?	N/A	N/A	Gutter Slope (%)	N/A
N/A	Gutter Lip Ht (in)	N/A	N/A	Gutter X Slope (%)	N/A
N/A	Painted X Walk1?	No	N/A	Painted X Walk2?	No
	X Walk 1 Direction	To E		X Walk 2 Direction	To N
N/A	X Walk 1 Width (in)	N/A	N/A	X Walk 2 Width (in)	N/A
	X Walk 1 Slope (%)	8.1		X Walk 2 Slope (%)	0.5
	X Walk 1 X Slope (%)	2.3		X Walk 2 X Slope (%)	7.0

N/A	Ramp inside XWalk1?	N/A	N/A	Ramp inside XWalk2?	N/A
	Road Slope (%)	5.5	N/A	Clear Space?	N/A
	Road X Slope (%)	4.8	N/A	Clear Space to XWalk (in)	N/A
N/A	Any Obstructions?	N/A	N/A	Storm Grate/Utility Hazard?	N/A
	Obstruction Type			Storm Grate/Utility Type	
		N/A			N/A
			Yes	Surface Condition? (G/P)	Good

**Remove & Replace Curb Ramp With Two New Directional Ramps or Equivalent.**

Total Cost: \$ 3200.00
