# Access Compliance Report

## Public Rights-of-Way

### (Curb Ramps)

Intersection ID: 9940	Main Street: KILDARE_DR	Cross Street: THE_PLAZA	Location: SW
ADA ID: 05A42BAE6CA7	Ramp Type: PerpDiag	Initial Pass/Fail: Fail	Overall Compliance: No
		Severity Score: 25

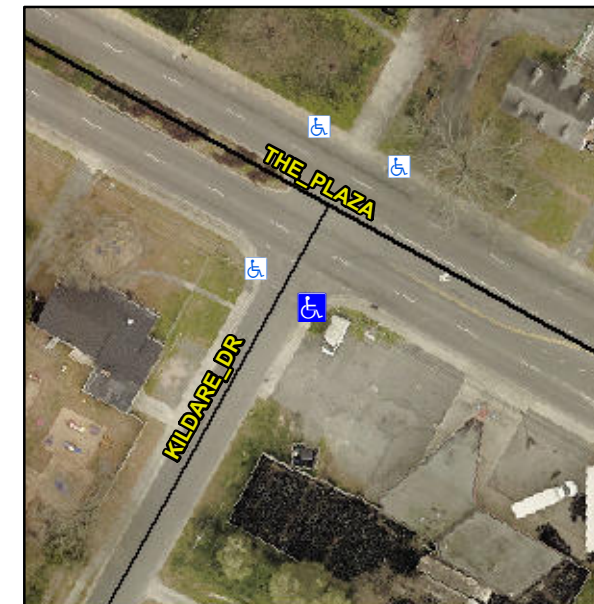
**Not Found, R304.2.2, R304.5.3**

Compliance	Description	Data	Compliance	Description	Data
N/A	Ramp Length (in)	59.5	No	Ramp Slope (%)	8.4
Yes	Ramp Width (in)	48.0	No	Ramp XSlope (%)	5.4
N/A	Flare Type LT	N/A	N/A	Flare Type RT	N/A
N/A	Flare Slope LT (%)	N/A	N/A	Flare Slope RT (%)	N/A
N/A	Flare Traversable LT?	N/A	N/A	Flare Traversable RT?	N/A
N/A	Landing Length (in)	N/A	N/A	DWS Provided?	N/A
N/A	Landing Width (in)	N/A	N/A	DWS Contrast?	N/A
N/A	Landing Slope (%)	N/A	N/A	DWS Length (in)	N/A
N/A	Landing X Slope (%)	N/A	N/A	DWS Full Width?	N/A
N/A	Landing Curb? (Y/N)	N/A	N/A	DWS Offset (in)	N/A
N/A	Shared Landing?	N/A			
N/A	Gutter Ponding?	N/A	N/A	Gutter Slope (%)	N/A
N/A	Gutter Lip Ht (in)	N/A	N/A	Gutter X Slope (%)	N/A
N/A	Painted X Walk1?	No	N/A	Painted X Walk2?	No
	X Walk 1 Direction	To NE		X Walk 2 Direction	To NW
N/A	X Walk 1 Width (in)	N/A	N/A	X Walk 2 Width (in)	N/A
	X Walk 1 Slope (%)	3.4		X Walk 2 Slope (%)	2.2
	X Walk 1 X Slope (%)	2.3		X Walk 2 X Slope (%)	3.0

N/A	Ramp inside XWalk1?	N/A	N/A	Ramp inside XWalk2?	N/A
	Road Slope (%)	4.1	N/A	Clear Space?	N/A
	Road X Slope (%)	0.5	N/A	Clear Space to XWalk (in)	N/A
N/A	Any Obstructions?	N/A	N/A	Storm Grate/Utility Hazard?	N/A
	Obstruction Type			Storm Grate/Utility Type	
		N/A			N/A
		Yes		Surface Condition? (G/P)	Good

**Remove & Replace Curb Ramp With Two New Directional Ramps or Equivalent.**
