# Access Compliance Report

## Public Rights-of-Way

### (Curb Ramps)

Intersection ID: 3337	Main Street: HUCKS_RD	Cross Street: SPRING_PARK_DR	Location: NE
ADA ID: 05AFA3EA92CB	Ramp Type: Perp	Initial Pass/Fail: Fail	Overall Compliance: No
		Severity Score: 22.5

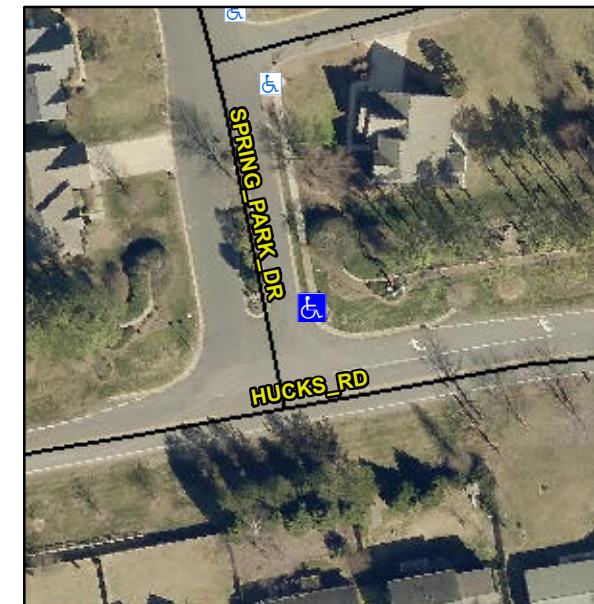
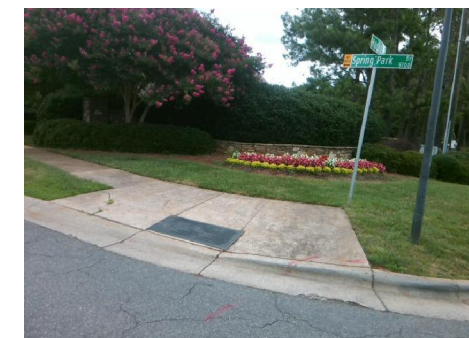
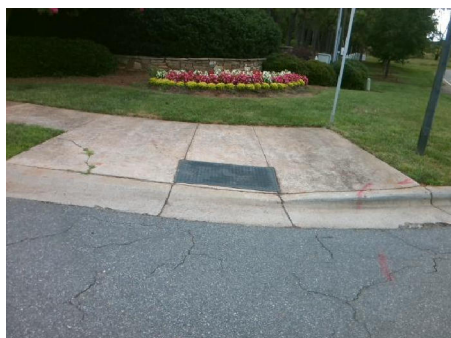
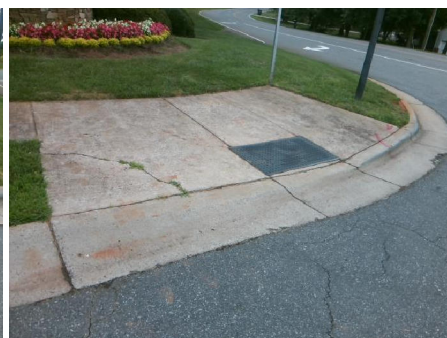
**Not Found, R304.5.1, R304.2.2, R304.5.3**

Compliance	Description	Data	Compliance	Description	Data
N/A	Ramp Length (in)	96.0	No	Ramp Slope (%)	8.5
No	Ramp Width (in)	37.5	No	Ramp XSlope (%)	5.0
N/A	Flare Type LT	N/A	N/A	Flare Type RT	N/A
N/A	Flare Slope LT (%)	N/A	N/A	Flare Slope RT (%)	N/A
N/A	Flare Traversable LT?	N/A	N/A	Flare Traversable RT?	N/A
N/A	Landing Length (in)	N/A	N/A	DWS Provided?	N/A
N/A	Landing Width (in)	N/A	N/A	DWS Contrast?	N/A
N/A	Landing Slope (%)	N/A	N/A	DWS Length (in)	N/A
N/A	Landing X Slope (%)	N/A	N/A	DWS Full Width?	N/A
N/A	Landing Curb? (Y/N)	N/A	N/A	DWS Offset (in)	N/A
N/A	Shared Landing?	N/A			
N/A	Gutter Ponding?	N/A	N/A	Gutter Slope (%)	N/A
N/A	Gutter Lip Ht (in)	N/A	N/A	Gutter X Slope (%)	N/A
N/A	Painted X Walk1?	No	N/A	Painted X Walk2?	N/A
	X Walk 1 Direction	To S		X Walk 2 Direction	N/A
N/A	X Walk 1 Width (in)	N/A	N/A	X Walk 2 Width (in)	N/A
	X Walk 1 Slope (%)	4.9		X Walk 2 Slope (%)	N/A
	X Walk 1 X Slope (%)	3.5		X Walk 2 X Slope (%)	N/A

N/A	Ramp inside XWalk1?	N/A	N/A	Ramp inside XWalk2?	N/A
	Road Slope (%)	N/A	N/A	Clear Space?	N/A
	Road X Slope (%)	N/A	N/A	Clear Space to XWalk (in)	N/A
N/A	Any Obstructions?	N/A	N/A	Storm Grate/Utility Hazard?	N/A
	Obstruction Type			Storm Grate/Utility Type	
		N/A			N/A
			Yes	Surface Condition? (G/P)	Good

**Remove & Replace Entire Ramp.**
