Access Compliance Report

Public Rights-of-Way (Curb Ramps)

Intersection ID: 20389	Main Street: SANDY_PORTER_RD	Cross Street: RED_HICKORY_LN	Location: S
ADA ID: 05B89D0E2A46	Ramp Type: Directional1	Initial Pass/Fail: Fail	Overall Compliance: No
		Severity Score: 1.25

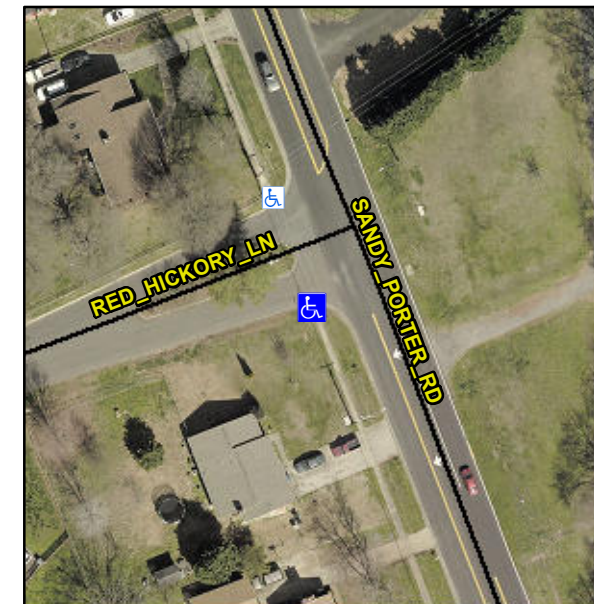
R304.5.3

Compliance	Description	Data	Compliance	Description	Data
N/A	Ramp Length (in)	61.0	N/A	Grade Break?	N/A
Yes	Ramp Width (in)	48.0	N/A	Grade Break Slope (%)	0.0
Yes	Ramp Slope (%)	3.1	N/A	Grade Break XSlope (%)	0.0
No	Ramp XSlope (%)	4.9			
N/A	Flare Type LT	N/A	N/A	Flare Type RT	N/A
N/A	Flare Slope LT (%)	N/A	N/A	Flare Slope RT (%)	0.0
N/A	Flare Traversable LT?	N/A	N/A	Flare Traversable RT?	N/A
N/A	Landing Length (in)	0.0	N/A	DWS Provided?	N/A
N/A	Landing Width (in)	0.0	N/A	DWS Contrast?	N/A
N/A	Landing Slope (%)	0.0	N/A	DWS Length (in)	N/A
N/A	Landing X Slope (%)	0.0	N/A	DWS Full Width?	N/A
N/A	Landing Curb? (Y/N)	N/A	N/A	DWS Offset LT (in)	N/A
N/A	Shared Landing?	N/A	N/A	DWS Offset RT (in)	N/A
N/A	Gutter Ponding?	0.0	N/A	Gutter Slope (%)	N/A
N/A	Gutter Lip Ht (in)	0.0	N/A	Gutter X Slope (%)	N/A
N/A	Painted X Walk1?	No		Road Slope (%)	6.3
	X Walk 1 Direction	To NW		Road X Slope (%)	2.8
	X Walk 1 Width (in)	N/A		Clear Space?	N/A

X Walk 1 Slope (%)	6.3	N/A	Clear Space to XWalk (in)	N/A
	X Walk 1 X Slope (%)	2.8	N/A	Storm Grate/Utility Hazard?	N/A
N/A	Ramp inside XWalk1?	N/A		Storm Grate/Utility Type	
N/A	Any Obstructions?	N/A			N/A
	Obstruction Type		Yes	Surface Condition? (G/P)	Good
			N/A	Curb Slope (%)	0.3

Remove & Replace Entire Ramp.

Total Cost: \$ 1600.00
