Access Compliance Report

Public Rights-of-Way

(Curb Ramps)

Intersection ID: 4753	Main Street: LOWEN_RD	Cross Street: SADDLE_TRAIL_LN	Location: E
ADA ID: 05BB97727EF1	Ramp Type: Perp	Initial Pass/Fail: Fail	Overall Compliance: No
			Severity Score: 46.25

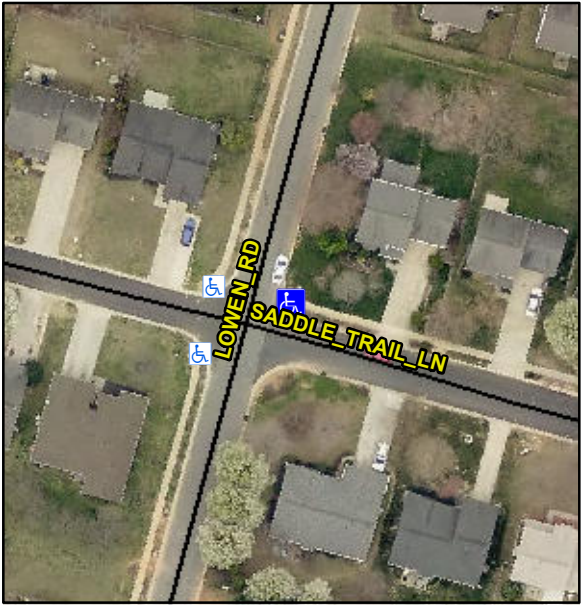
Possible Solutions:				
	Remove & Replace Entire Ramp.				
	Surveyor Notes:				
	N/A				
	PROW/ADA:				
	Not Found, R304.5.1, R304.2.2, R304.5.3				
	Street 1 Name	LOWEN RD			
	Stop Condition-Street 2	None			
	Street 2 Name	N/A			
	Stop Condition-Street 1	N/A			
Total Cost:		\$	1850.00		
Compliance	Description	Data	Compliance	Description	Data
N/A	Ramp Length (in)	51.5	No	Ramp Slope (%)	11.8
No	Ramp Width (in)	36.0	No	Ramp XSlope (%)	9.6
N/A	Flare Type LT	N/A	N/A	Flare Type RT	N/A
N/A	Flare Slope LT (%)	N/A	N/A	Flare Slope RT (%)	N/A
N/A	Flare Traversable LT?	N/A	N/A	Flare Traversable RT?	N/A
N/A	Landing Length (in)	N/A	N/A	DWS Provided?	N/A
N/A	Landing Width (in)	N/A	N/A	DWS Contrast?	N/A
N/A	Landing Slope (%)	N/A	N/A	DWS Length (in)	N/A
N/A	Landing X Slope (%)	N/A	N/A	DWS Full Width?	N/A
N/A	Landing Curb? (Y/N)	N/A	N/A	DWS Offset (in)	N/A

N/A	Shared Landing?	N/A			
N/A	Gutter Ponding?	N/A	N/A	Gutter Slope (%)	N/A
N/A	Gutter Lip Ht (in)	N/A	N/A	Gutter X Slope (%)	N/A
N/A	Painted X Walk1?	No	N/A	Painted X Walk2?	N/A
	X Walk 1 Direction	To NW		X Walk 2 Direction	N/A
N/A	X Walk 1 Width (in)	N/A	N/A	X Walk 2 Width (in)	N/A
	X Walk 1 Slope (%)	2.1		X Walk 2 Slope (%)	N/A
	X Walk 1 X Slope (%)	10.5		X Walk 2 X Slope (%)	N/A
N/A	Ramp inside XWalk1?	N/A	N/A	Ramp inside XWalk2?	N/A
	Road Slope (%)	N/A	N/A	Clear Space?	N/A
	Road X Slope (%)	N/A	N/A	Clear Space to XWalk (in)	N/A
N/A	Any Obstructions?	N/A	N/A	Storm Grate/Utility Hazard?	N/A
	Obstruction Type			Storm Grate/Utility Type	
		N/A			N/A
			Yes	Surface Condition? (G/P)	Good
