Intersection ID: 20158	Main Street: GAULEY_CR	Cross Street: GRIERS_FORK_DR	Location:	SE
ADA ID: 05CE8FDD0E22	Ramp Type: PerpDiag	Initial Pass/Fail: Fail	Overall Compliance: No	Severity Score: 8.75

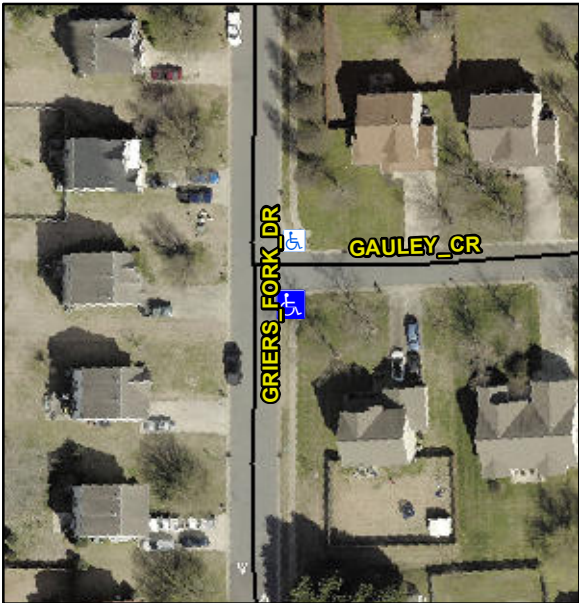
Possible Solutions:		Remove & Replace Curb Ramp With Two New Directional Ramps or Equivalent.			Compliance	Description	Data	Compliance	Description	Data
	Surveyor Notes:		N/A			N/A	Ramp Length (in)	48.0	Yes	Ramp Slope (%)	5.9
	PROW/ADA:		R304.5.1			No	Ramp Width (in)	45.0	Yes	Ramp XSlope (%)	1.0
						N/A	Flare Type LT	N/A	N/A	Flare Type RT	N/A
						N/A	Flare Slope LT (%)	N/A	N/A	Flare Slope RT (%)	N/A
						N/A	Flare Traversable LT?	N/A	N/A	Flare Traversable RT?	N/A
						N/A	Landing Length (in)	N/A	N/A	DWS Provided?	N/A
						N/A	Landing Width (in)	N/A	N/A	DWS Contrast?	N/A
						N/A	Landing Slope (%)	N/A	N/A	DWS Length (in)	N/A
						N/A	Landing X Slope (%)	N/A	N/A	DWS Full Width?	N/A
					N/A	Landing Curb? (Y/N)	N/A	N/A	DWS Offset (in)	N/A	
					N/A	Shared Landing?	N/A				
					N/A	Gutter Ponding?	N/A	N/A	Gutter Slope (%)	N/A

N/A	Gutter Lip Ht (in)	N/A	N/A	Gutter X Slope (%)	N/A	
					N/A	Painted X Walk1?	No	N/A	Painted X Walk2?	No	
						X Walk 1 Direction	To NE		X Walk 2 Direction	To NW	
					N/A	X Walk 1 Width (in)	N/A	N/A	X Walk 2 Width (in)	N/A	
						X Walk 1 Slope (%)	0.8		X Walk 2 Slope (%)	3.0	
						X Walk 1 X Slope (%)	1.6		X Walk 2 X Slope (%)	1.3	
					N/A	Ramp inside XWalk1?	N/A	N/A	Ramp inside XWalk2?	N/A	
						Road Slope (%)	1.1	N/A	Clear Space?	N/A	
						Road X Slope (%)	2.6	N/A	Clear Space to XWalk (in)	N/A	
					N/A	Any Obstructions?	N/A	N/A	Storm Grate/Utility Hazard?	N/A	
						Obstruction Type			Storm Grate/Utility Type		
							N/A			N/A	
								Yes	Surface Condition? (G/P)	Good
