## Access Compliance Report Public Rights-of-Way (Curb Ramps)

Intersection ID: 47226 Main Street: OAKSHIRE\_CR Cross Street: VALLEYDALE\_RD Location: E

ADA ID: 05DC72D17919 Ramp Type: PerpDiag Initial Pass/Fail: Fail Overall Compliance: No Severity Score: 13.75

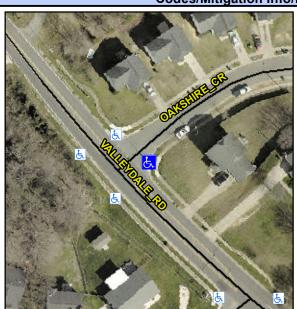
Compliance Description <u>Data</u> Compliance Description Data No N/A Ramp Length (in) 46.0 Ramp Slope (%) 11.7 No Ramp XSlope (%) Yes Ramp Width (in) 56.0 3.6 N/A N/A Flare Type LT N/A Flare Type RT N/A N/A N/A N/A Flare Slope RT (%) N/A Flare Slope LT (%) N/A Flare Traversable LT? N/A N/A Flare Traversable RT? N/A N/A N/A N/A DWS Provided? N/A Landing Length (in) N/A Landing Width (in) N/A N/A **DWS Contrast?** N/A N/A N/A Landing Slope (%) N/A DWS Length (in) N/A N/A Landing X Slope (%) N/A N/A DWS Full Width? N/A N/A Landing Curb? (Y/N) N/A N/A DWS Offset (in) N/A N/A N/A Shared Landing? N/A **Gutter Ponding?** N/A N/A Gutter Slope (%) N/A N/A Gutter Lip Ht (in) N/A N/A Gutter X Slope (%) N/A N/A Painted X Walk1? No N/A Painted X Walk2? No X Walk 1 Direction To SW X Walk 2 Direction To NW N/A N/A X Walk 1 Width (in) X Walk 2 Width (in) N/A X Walk 1 Slope (%) X Walk 2 Slope (%) 1.0 4.1 X Walk 1 X Slope (%) 2.9 X Walk 2 X Slope (%) 3.0 N/A N/A N/A Ramp inside XWalk2? N/A Ramp inside XWalk1? Road Slope (%) 3.9 N/A Clear Space? N/A N/A Road X Slope (%) 0.8 Clear Space to XWalk (in) N/A N/A N/A N/A Any Obstructions? Storm Grate/Utility Hazard? N/A **Obstruction Type** Storm Grate/Utility Type N/A N/A Yes Surface Condition? (G/P) Good

Remove & Replace Curb Ramp With
Two New Directional Ramps or
Equivalent.

PROW/ADA:
Not Found, R304.2.2, R304.5.3
