Access Compliance Report

Public Rights-of-Way

(Curb Ramps)

Intersection ID: 2927	Main Street: DOWNFIELD_WOOD_DR	Cross Street: RIDGEFIELD_DR	Location: SE
ADA ID: 05DF2C6D7751	Ramp Type: Perp	Initial Pass/Fail: Pass	Overall Compliance: No
Codes/Mitigation Info/Possible Solution		Field Measurements/Component Compliance

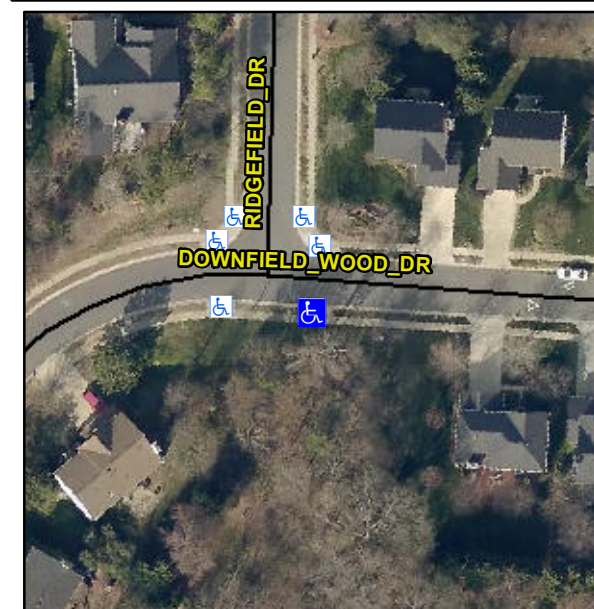
Not Found, R304.5.3, R305

Compliance	Description	Data	Compliance	Description	Data
N/A	Ramp Length (in)	48.0	Yes	Ramp Slope (%)	5.3
Yes	Ramp Width (in)	95.0	No	Ramp XSlope (%)	2.1
N/A	Flare Type LT	Sloped	N/A	Flare Type RT	N/A
N/A	Flare Slope LT (%)	3.5	Yes	Flare Slope RT (%)	1.1
N/A	Flare Traversable LT?	Yes	N/A	Flare Traversable RT?	Yes
Yes	Landing Length (in)	48.0	No	DWS Provided?	No
Yes	Landing Width (in)	95.0	N/A	DWS Contrast?	No
Yes	Landing Slope (%)	1.7	N/A	DWS Length (in)	N/A
No	Landing X Slope (%)	2.1	N/A	DWS Full Width?	No
N/A	Landing Curb? (Y/N)	No	N/A	DWS Offset (in)	N/A
N/A	Shared Landing?	No			
Yes	Gutter Ponding?	No	Yes	Gutter Slope (%)	3.1
Yes	Gutter Lip Ht (in)	0.0	Yes	Gutter X Slope (%)	2.0
N/A	Painted X Walk1?	No	N/A	Painted X Walk2?	N/A
	X Walk 1 Direction	To N		X Walk 2 Direction	N/A
N/A	X Walk 1 Width (in)	N/A	N/A	X Walk 2 Width (in)	N/A
	X Walk 1 Slope (%)	3.6		X Walk 2 Slope (%)	N/A
	X Walk 1 X Slope (%)	1.3		X Walk 2 X Slope (%)	N/A

N/A	Ramp inside XWalk1?	N/A	N/A	Ramp inside XWalk2?	N/A
	Road Slope (%)	N/A	N/A	Clear Space?	Yes
	Road X Slope (%)	N/A	N/A	Clear Space to XWalk (in)	N/A
Yes	Any Obstructions?	No	Yes	Storm Grate/Utility Hazard?	No
	Obstruction Type			Storm Grate/Utility Type	
		N/A			N/A
			Yes	Surface Condition? (G/P)	Good

Possible Solutions:

Remove & Replace Entire Ramp.
